1 **Features of crevasse splay deposits and sedimentary processes associated with**
2 **levee breaching by the October 2019 flood of the Chikuma River, Central Japan**

19 **ABSTRACT**

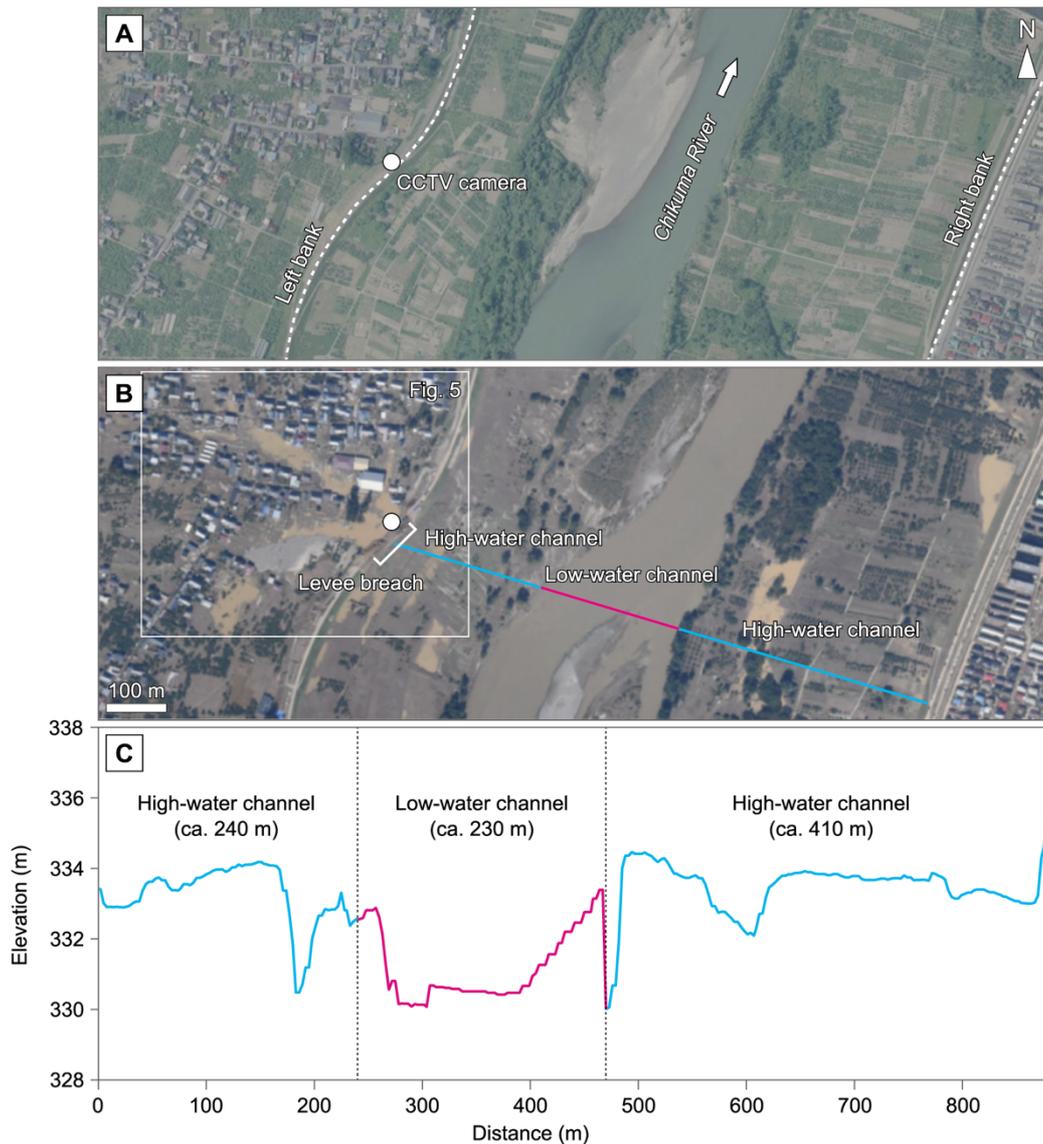
126 On the midstream left bank of the Chikuma River (the study area), closed-circuit
127 Television (CCTV) camera installed on the breached levee (Fig. 2A and B) indicated
128 that river water overflowed the levee at 0:55 am on October 13 (Investigation
129 Committee on the Chikuma River Levee, 2020) (Fig. 4). The last image acquired by the
130 CCTV camera was taken at 2:15 am, and the Chikuma River Office made an urgent
131 announcement about the levee breach at 5:30 am, i.e., the levee breach occurred
132 between 2:15 am and 5:30 am on October 13 (Fig. 4). The 30 m wide left bank levee

133 revetment was breached over a length of 70 m (Figs. 2B, 5A, and 6A), resulting in
134 inundation of the 6 km wide floodplain up to a distance of 2.23 km from the breached
135 levee (Fig. 3B). The area of the overflow is estimated to have reached up to 400 m
136 upstream and up to 900 m downstream from the breached levee (Fig. 3B; Investigation
137 Committee on the Chikuma River Levee, 2020).

625 **Fig. 2.** Aerial photographs around the study site. (A) Before the flooding (photograph
626 taken in 2010). (B) After the flooding (photograph taken on October 16, 2019)
627 (Geospatial Information Authority of Japan, 2019). Locations of low-water (pink line)
628 and high-water (blue line) channels, CCTV camera, and the levee breach are shown. (C)
629 Channel cross-section and width during low water and high water stages (created from
630 DEM data provided by the Geospatial Information Authority of Japan).

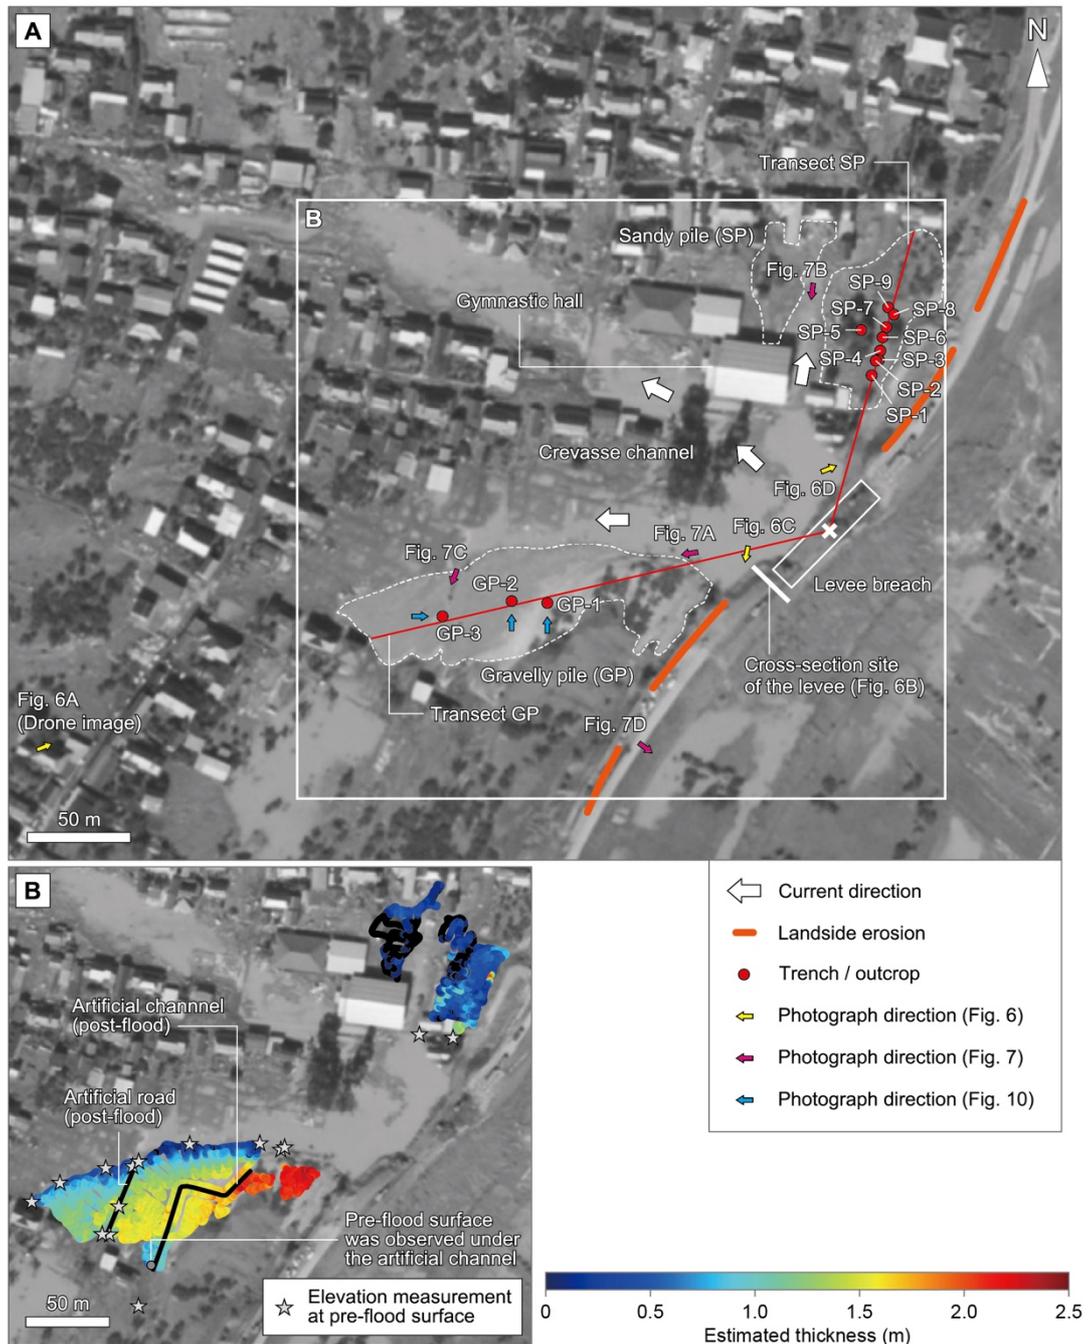
199 The thickness of the piles was estimated from the difference in elevation between
200 the pile surface and pre-flood ground surface around the piles. The ProMark 120 was
201 used to measure the elevation of the crevasse piles and pre-flood ground surface (Fig.
202 5B). We obtained the surface elevations of the piles by walking through them with the
203 ProMark 120, which recorded the location, and elevation every second. Pre-flood
204 surface elevations were measured based on the averages of thirteen points for the
205 gravelly pile and two points for the sandy pile (Fig. 5B).

292 Proximal crevasse splay deposits observed in the study area included gravelly or
293 sandy sediment piles, and were distributed both to the south (upstream) and north
294 (downstream) of the breached levee (Fig. 5A). The upstream gravelly pile was
295 preserved on apple orchards and cultivated areas south of the breached levee and was
296 estimated to cover an area of 6,630 m² according to image analysis. The downstream

645 **Fig. 5.** (A) Aerial photograph around the breached levee (Geospatial Information
 646 Authority of Japan, 2019), showing the locations of the gravelly pile (GP), sandy pile
 647 (SP), transects GP and SP, and the surveyed trenches and outcrops. Yellow, pink, and
 648 blue arrows represent photograph directions in Figs. 6, 7, and 10, respectively. (B)
 649 Estimated thickness of the gravelly and sandy piles. Pre-flood surface elevation was
 650 measured at the points indicated with stars.

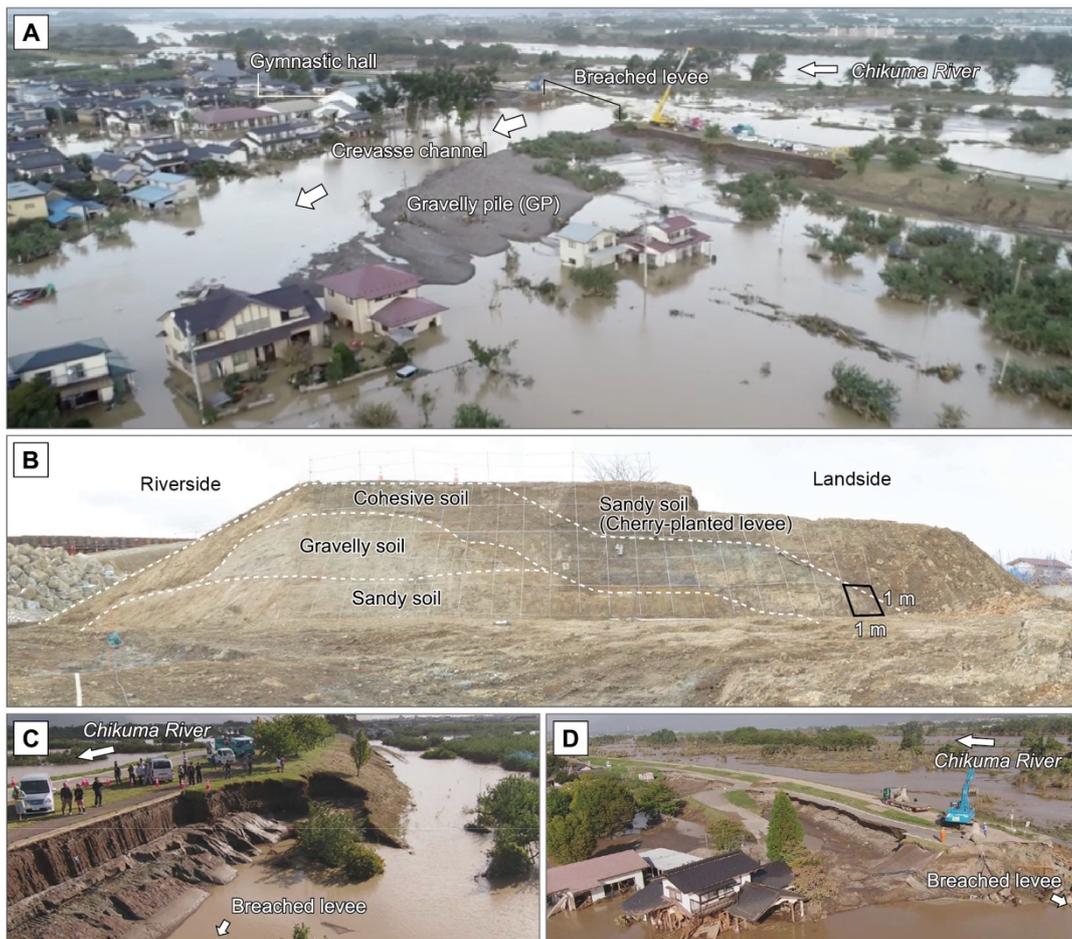
239 The 30 m wide and 5.0–5.5 m high levee revetment in the study site was fully
240 breached over a distance of 70 m (Figs. 2, 5A, and 6A). Erosion was observed in the
241 landside region around the breached levee up to 300 m upstream and 150 m
242 downstream (Figs. 5A and 6C, D), whereas significant erosion was not observed in the
243 riverside region (Investigation Committee on the Chikuma River Levee, 2020; Ohtsuka
244 et al., 2021). Crevasse channels developed from the breached levee toward the
245 floodplain and floodwater flowed mainly in three directions, influenced by the presence
246 of artificial barricades, such as dwellings and a gymnastics hall (Figs. 5A, 6A, and 7A,
247 B). These buildings were eventually destroyed by the floodwater (Figs. 6D and 7B).
248 The channel eroded up to 3 m of pre-flood soil within 50 m of the breached levee
249 (Investigation Committee on the Chikuma River Levee, 2020) such that only a 0.5 cm

495 thus, the overflow continued for at least 80 minutes. It is presumed that the landside
496 caused by erosion of the levee also began during this time (Figs. 5A, 6C, D, and 18A).
497 Of the factors contributing to the levee breach, external (landside) erosion due to
498 overflowing has been found to be the most frequent (Özer et al., 2020).

652 **Fig. 6.** (A) Drone image taken at approximately 5 pm on October 13 by the Geospatial
653 Information Authority of Japan. (B) Upstream cross section of the breached levee. (C)
654 Photograph of the upstream side of the breached levee. (D) Photograph of the
655 downstream side of the breached levee. Photograph locations and directions are
656 indicated in Fig. 5. Photographs were taken on (B) February 8, 2020, and (C and D)
657 October 13, 2019, by the Investigation Committee on the Chikuma River Levee (2020).

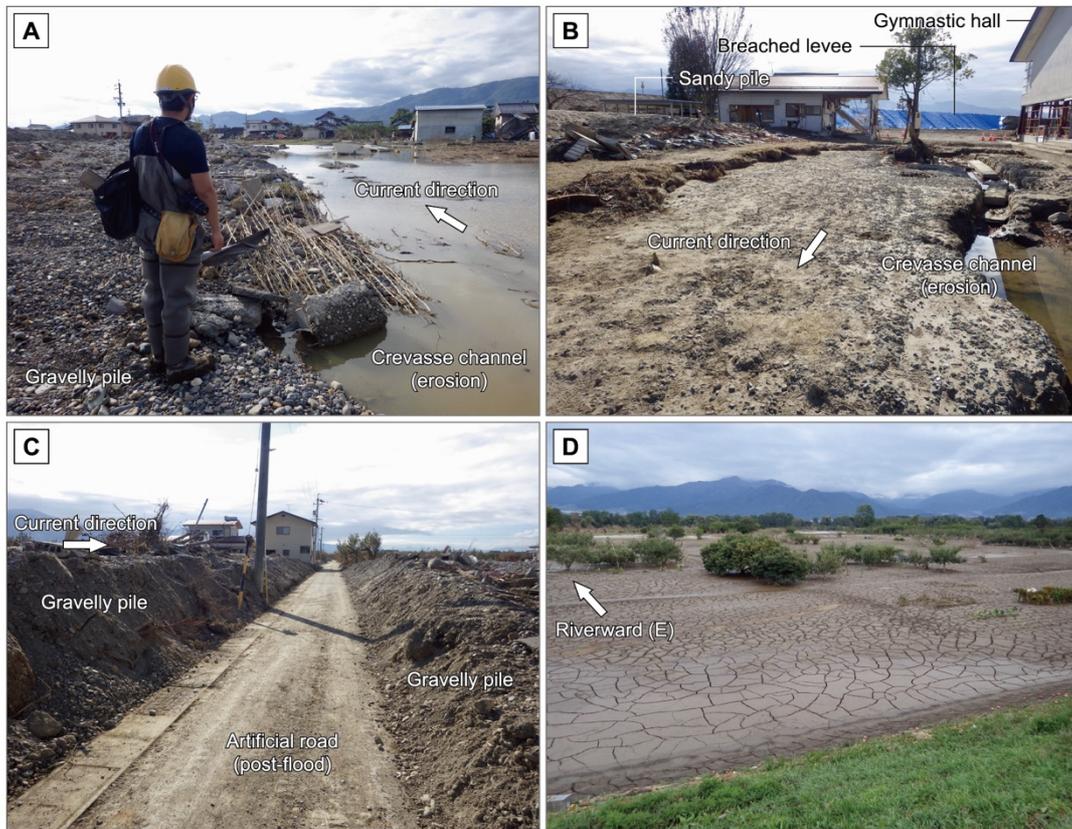
252 Sand and gravel sediment piles were observed at the outer side of the crevasse
253 channel in aerial photographs acquired after the flooding (Figs. 2B, 5A, and 6A).
254 Restoration work started immediately after the event and created the road and draining
255 channel in the southern gravelly sediment pile (Figs. 5B and 7C), enabling observations
256 of cross sections through the sediment pile at GP-1–3. On the other hand, the high-water
257 channel on the river side of the levee was covered with muddy sediment, and cracks
258 were observed only at the surface (Fig. 7D).

561 pile (Figs. 7A, 10, and 11), suggesting that the stagnant water level was below the
562 surface of the gravelly pile. The finer sand layer and mud cap observed at the surface of
563 the downstream sandy pile were probably deposited during this stage (Figs. 12–14). The
564 absence of deposits near the inundation limit implies that the stagnant water stood for
565 only a short period of time in this area before receding, since the elevation of this area is
566 higher than that at which the thick mud was observed (Fig. 8).

659 **Fig. 7.** Photographs of (A) crevasse channel and gravelly pile (proximal splay), (B)
660 crevasse channel and sandy pile (proximal splay), (C) artificial road in the gravelly pile
661 (proximal splay) created after the flooding, and (D) muddy deposit preserved in the
662 high-water channel. Photograph locations and directions are indicated in Fig. 5.

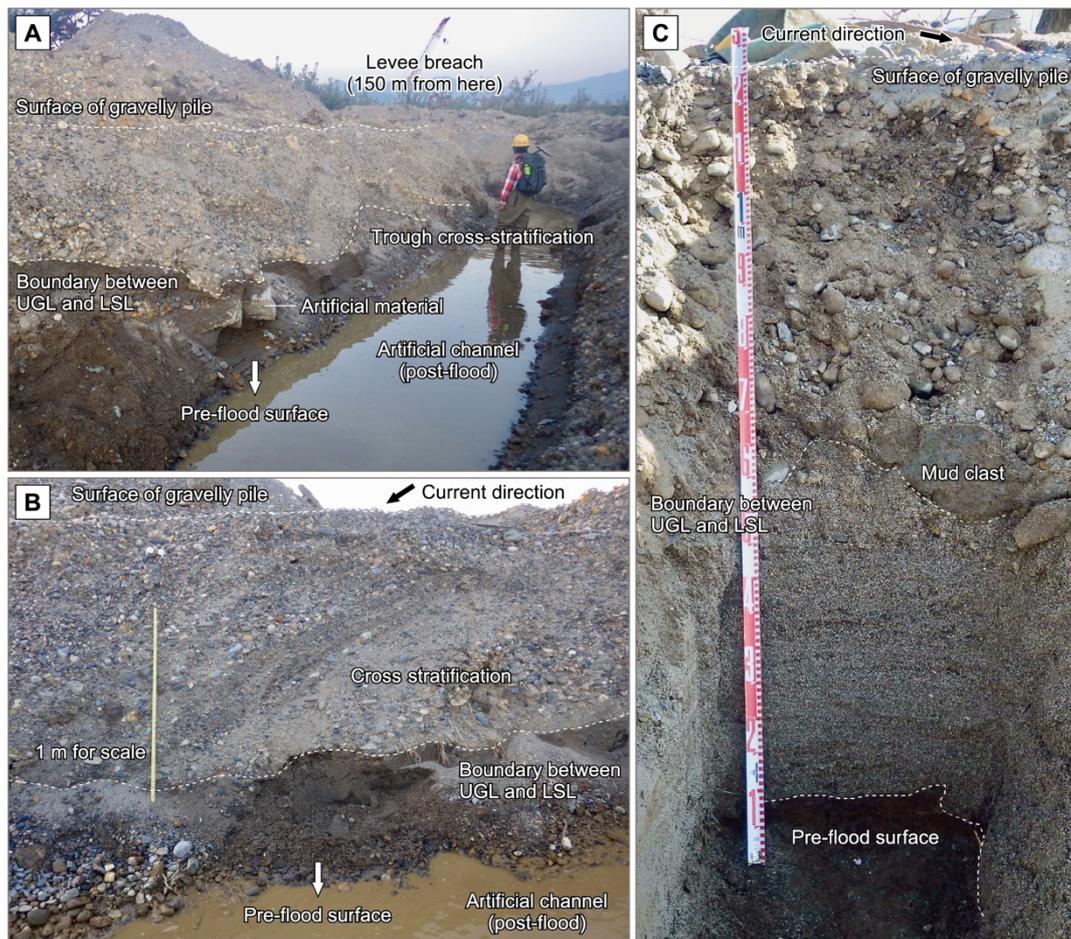
313 The crevasse splay deposits in the gravelly pile consisted of lower sand layer
314 (LSL) and upper gravel layer (UGL) bounded by a sharp interface (Figs. 10 and 11A).
315 The interface between pre-flood soils and the lower sand layer was observed at GP-3,
316 but could not be confirmed at localities GP-1 and GP-2 due to the high-water level in
317 the artificial channel. Artificial materials and mud clasts were sometimes observed in
318 the crevasse splay deposits, especially around the interface between lower sand and
319 upper gravel layers. The thickness of the crevasse splay deposits ranged from 110 to
320 200 cm at GP-1–3, of which the lower sand layer accounted for 40–130 cm and the
321 upper gravel layer for 70–130 cm (Fig. 11A). Although these data were obtained from
322 only three sites, the average thickness of 150 cm did not differ significantly from that
323 estimated from the elevation data (Fig. 5B). The thickness estimated from the elevation

330 toward the top (Fig. 11C). At GP-1 and GP-2, where a wide cross section could be
331 observed, concave and trough cross-stratification was observed (Fig. 10A and B).

517 The upstream gravelly pile is characterized by lower sand and upper gravel layers
518 with a clear boundary (Fig. 10), implying that the levee breach can be divided into two
519 phases. As noted above, macroscopic changes in the thickness of the sand layer indicate
520 that the lower layer did not form during the overflow stage but during this early
521 breaching stage. The presence of destroyed artificial materials in the sand layer at GP-1
522 further supports this (Fig. 10A). The presence of sandy soil on the outer side of the
523 levee revetment structure suggests the eroded sand particles were transported during this
524 stage (Figs. 6B and 18B). In the lower sand layer at GP-3, the content rate of granules is
525 larger above 86 cm depth (Fig. 11B), suggesting either that the flow strength increased
526 around this depth, allowing coarser-grained granules to reach this area, or that bank

679 **Fig. 10.** Photographs showing crevasse splay deposits at (A) GP-1, (B) GP-2, and (C)

680 GP-3 in the gravelly pile (proximal splay). Photograph locations and directions are

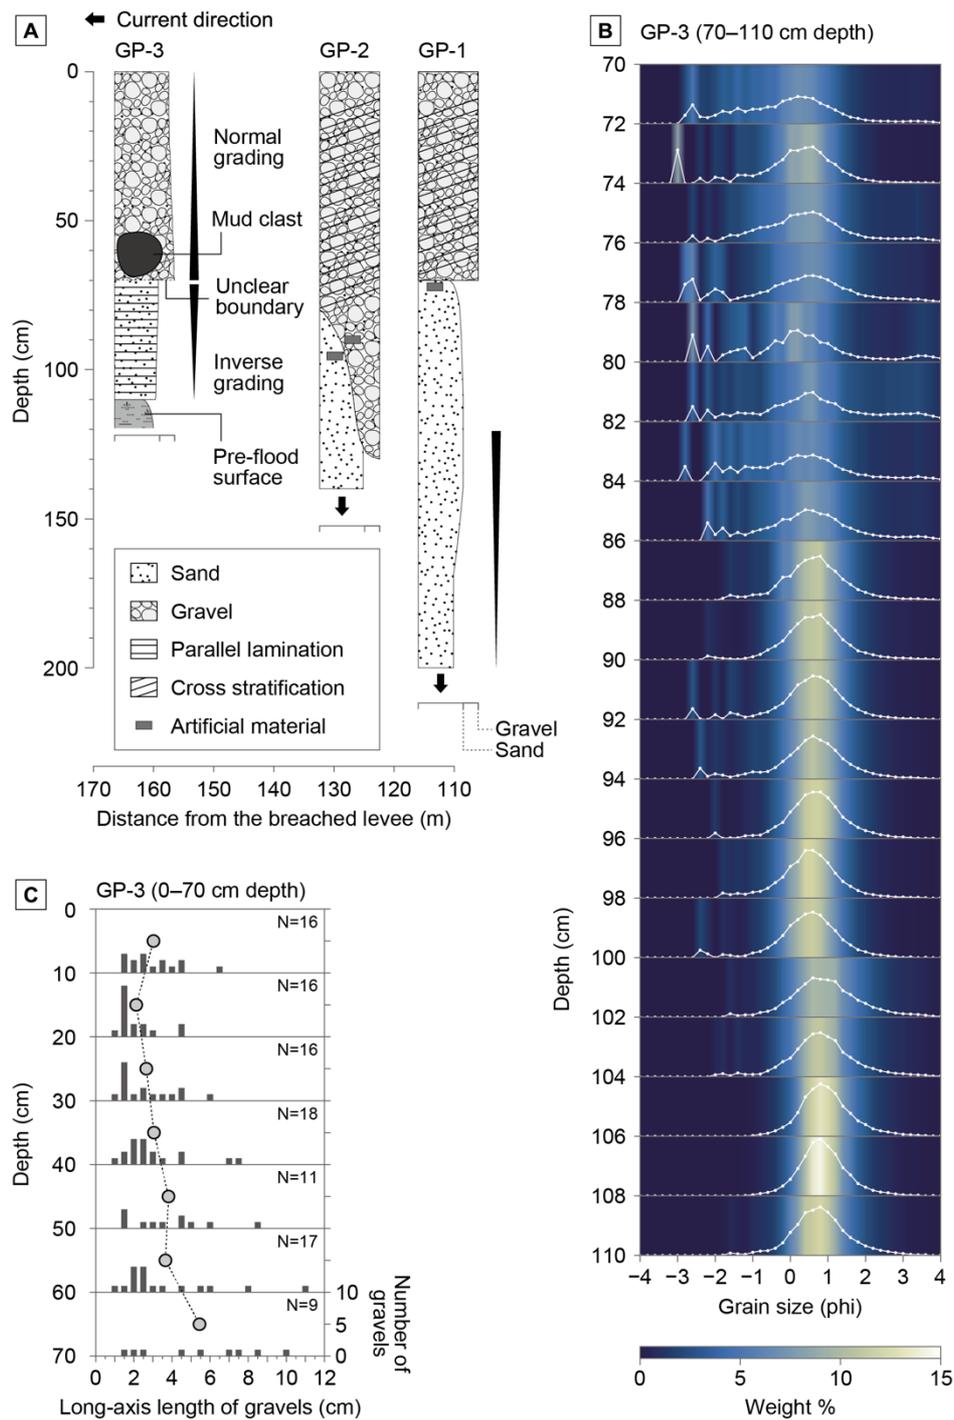
683 **Fig. 11.** (A) Columnar section of crevasse splay deposits at GP-1–3 in the upstream
 684 gravelly pile (proximal splay). (B) Vertical change in grain size distribution of the
 685 crevasse splays deposit at 70–110 cm depth at GP-3. (C) Distribution and average (gray
 686 circle) long-axis length of gravels in the crevasse splay deposit at 0–70 cm depth at GP-
 687 3.

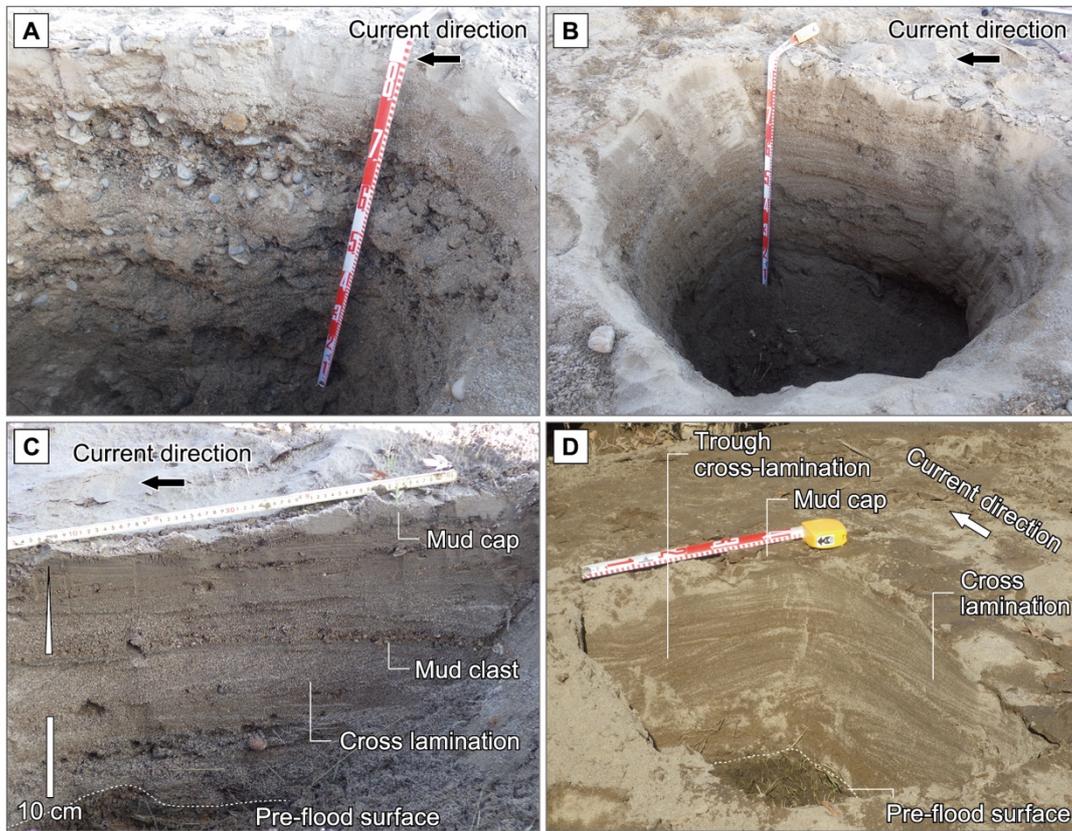
332 Crevasse splay deposits in the downstream sandy pile, the thickness of which
333 ranged from 6.5 to 110 cm, exhibited various sedimentary facies (Figs. 12 and 13). At
334 SP-1, SP-2, and SP-5, thicker gravelly deposits, and multiple inversely graded structures
335 were observed. Cross-laminated sand layers were observed at SP-3, SP-4, and SP-8. An
336 overlap of the finer sand layer and the mud cap at the surface was common to most sites
337 studied herein (Figs. 13 and 14).

689 **Fig. 12.** Photographs showing crevasse splay deposits at (A) SP-1, (B) SP-2, (C) SP-3,
690 and (D) SP-8 in the sandy pile (proximal splay).

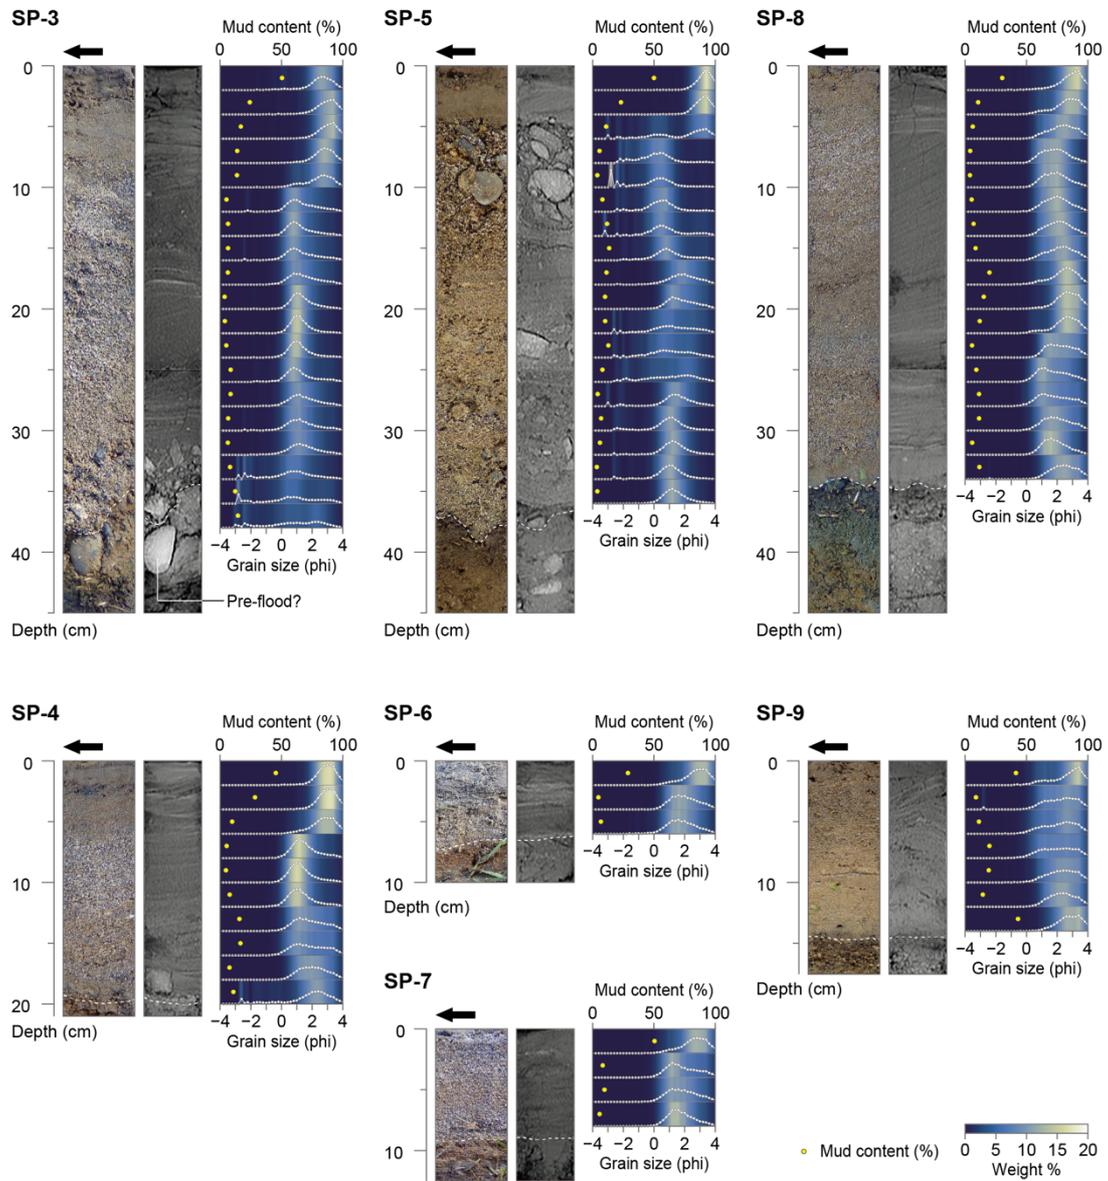
695 **Fig. 14.** Photograph (geoslicer sample), CT image, grain size distribution, and mud
 696 content (yellow) of crevasse splay deposits in the sandy pile (proximal splay).

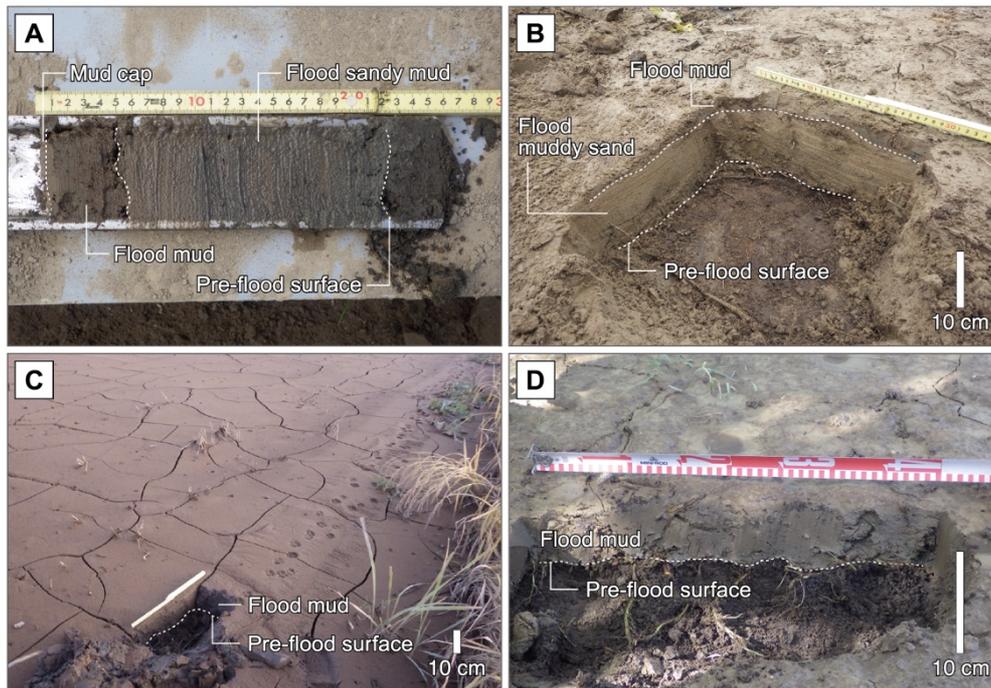
347 At distance from the levee, distal crevasse splay deposits composed of massive
348 mud were observed at A-7–13 along the central transect A–A' (Figs. 8A and 15C).
349 These distal deposits were also observed along transects B–B' and C–C' 1 km north and
350 south of the central transect A–A' (Figs. 8C, D, and 15D). The deposits were not
351 observed to thin away from the levee in either transect (Figs. 8 and 9C, D) and no
352 deposit was observed near the limit of the inundation area along transects A–A' and B–
353 B' (Fig. 8A and C).

698 **Fig. 15.** Photographs of crevasse splay deposits at (A) trench A-2 (medial splay), (B)
699 trench E-2 (medial splay), (C) trench A-9 (distal splay), and (D) trench C-4 (distal
700 splay).
