The Importance of Preserving Small Heritage Sites: the Case of La Tuiza Sanctuary (Zamora, Spain)

Received: 27 October 2021 / Accepted: 28 March 2022 / Published online: 8 April 2022

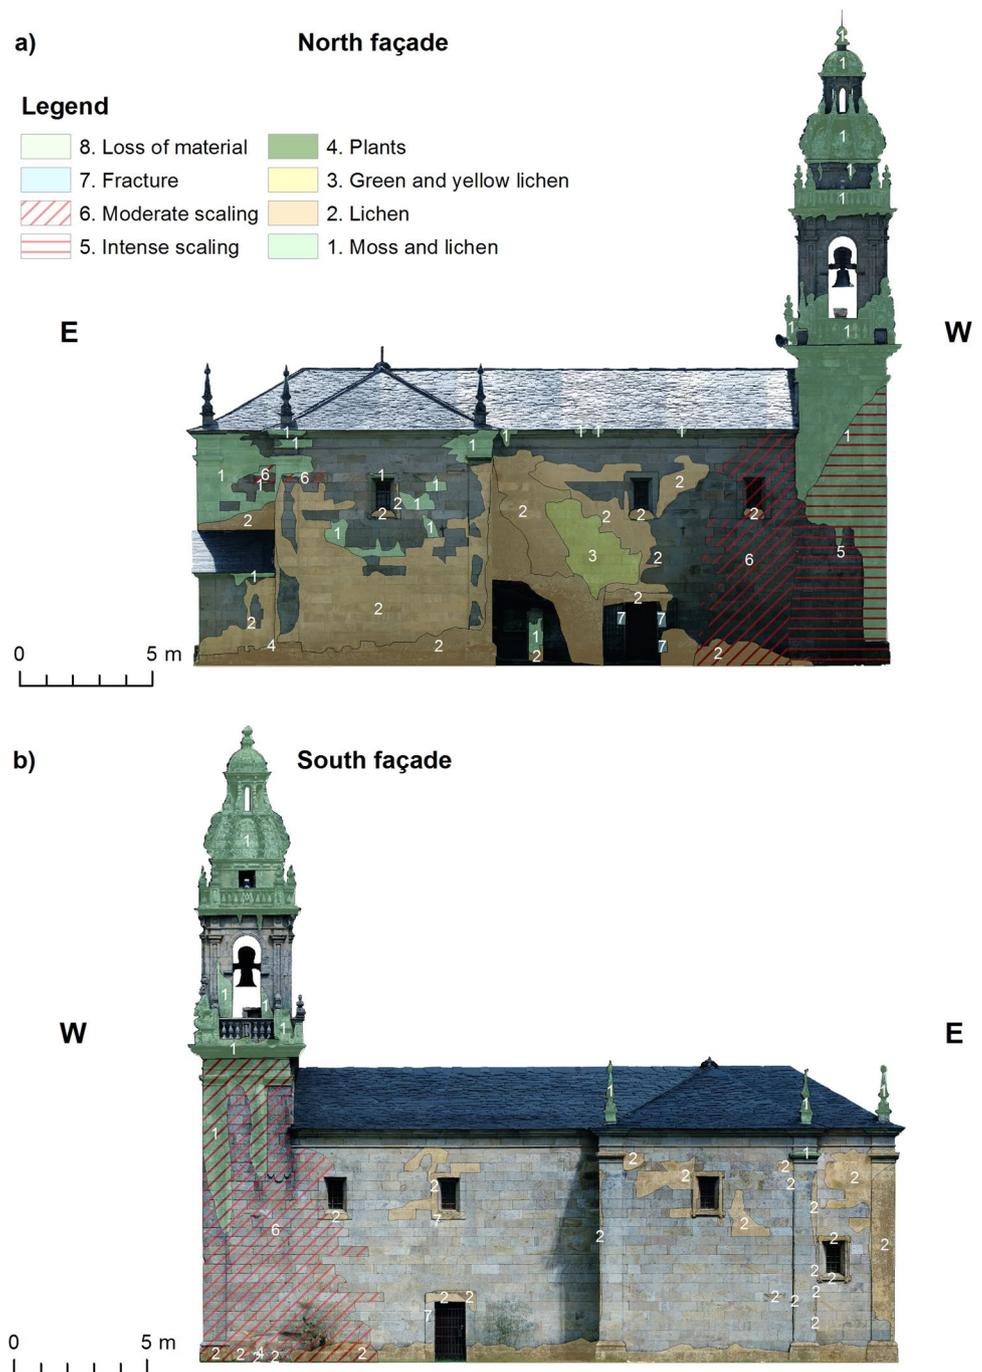
Figure 5 shows the mapping of the degradation forms of the north (a) and south (b) façade; Fig. 6 shows the east (a) and west (b) façade; and Fig. 7 (a–f) shows some examples of decay elements.

The sanctuary presents different states of conservation depending on observations of the different orientations of the building, with the north and west sides being the most affected. The most common and abundant recognisable forms of deterioration are due to biological colonisation, including lichens, mosses, and vascular plants (ferns, ivies, etc.). The intensity of the biological colonisation varies from one area to another, with the greatest affection on the north side. It is more frequently located in the joints between ash-lars, on the upper surface of the cornices, all around the base of the building (ranging in height from 1.5 m in the north to 0.8 m in the south) which is affected by capillary rise, and on the bell tower, where this intense biological colonisation blackens the stone (Fig. 7a). Once the XRD analyses (Lu-6, Table 2) ruled out that all the blackish tones could be due to the formation of a black crust, which would have been interpreted as due to the development of salts such as gypsum (Pozo-Antonio et al. 2019), it can be deduced that these discolourations are due to the presence of organisms, such as lichens and/or mosses. Other areas where biological colonisation is concentrated are the intersection between the walls and the roof slate in the transept, both on the north side (Fig. 7b) and on the east side. Additionally, the north façade is also covered by green-yellow lichens (Fig. 7c). On the west façade and on the west area of the north and south façade, together with the presence of vascular plants (Fig. 7d), intense detachment, accompanied by scaling, also with varying intensity, should be noted, with the west façade being the most affected (Fig. 7d, e). Some of these scales were sampled (Lu-4) and analysed by XRD, but no salts were found; only the same mineral components characteristic of granites, as illustrated in Table 2. Occasionally, it is also possible to observe cracks and deformation, that is, fractures (Fig. 7f), mainly in the areas close to the doors

Fig. 5 Orthophoto mapping of the main forms of degradation observed on the north (a) and south (b) façade

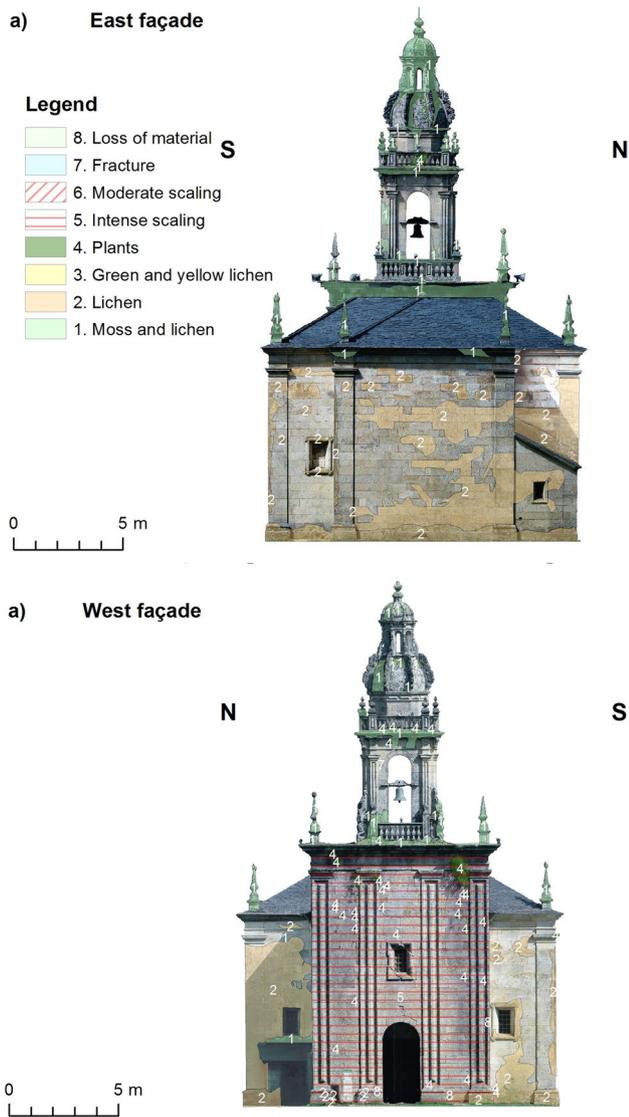
Fig. 6 Orthophoto mapping of the main forms of degradation observed on the east (a) and west (b) façade

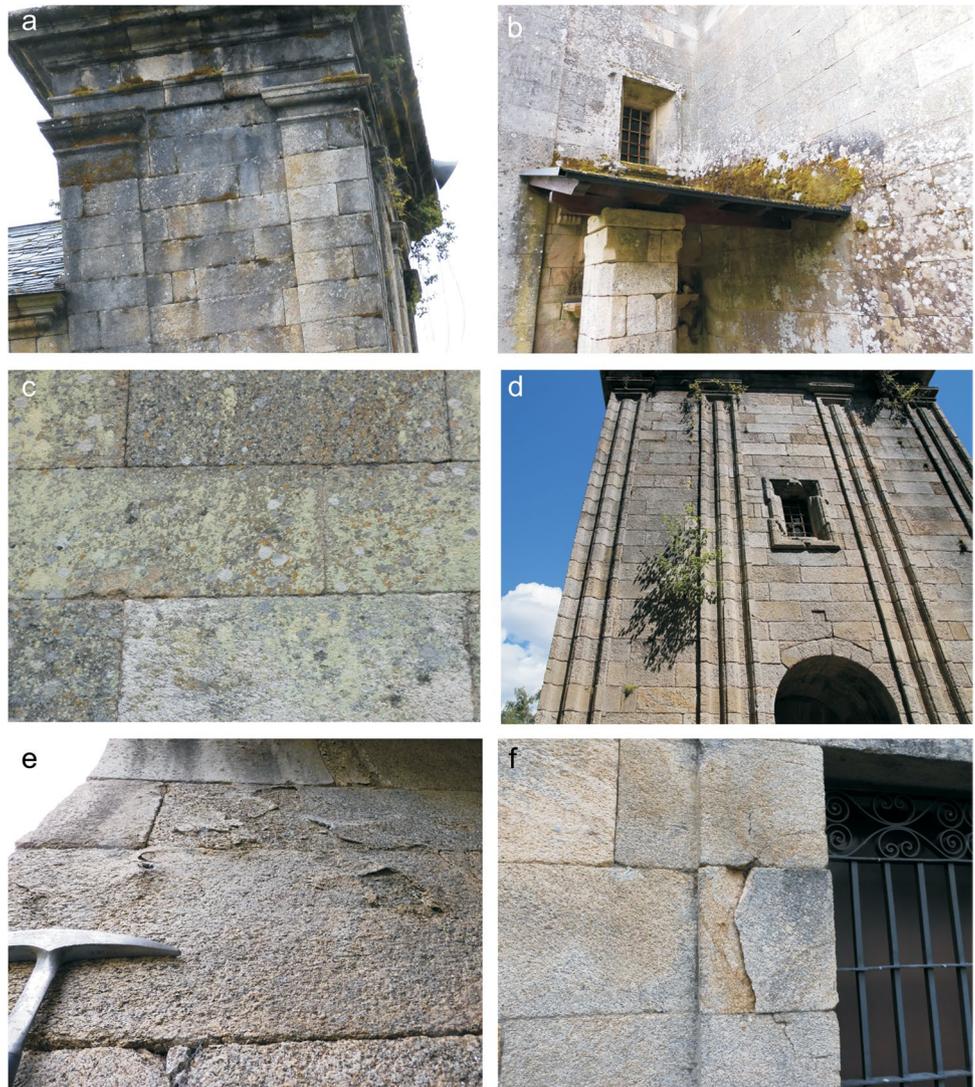
Fig. 7 Main deterioration forms. **a** Lichens, moss and vascular plants growing on the bell tower blackening the stone. **b** Moss and lichens on and above a slate roof. **c** Green and yellow lichens on the north façade. **d** Vascular plants and general view of the scaling on the west side façade. **e** Detail of the scaling. **f** fracture by the anchors of an iron fence

Despite the above interpretation of the decay, the main cause of the deterioration of the building is biological colonisation, mainly due to lichens but also moss and vascular plants. Their presence varies in intensity in the different areas of the building and reaches its greatest development in the base of the building of the north side, reaching up to 1.5 m in height, on the bell tower, where the presence of moisture is greater, on the cornices, and on the roof on the top of the transepts. In the first-mentioned area, because of the continuous supply of water from the ground due to the continuous watering of the lawn, as described above. In the other areas, due to poor drainage of rainwater, which causes moisture accumulation, especially in the joints between the roof slate and the granite of the ashlar and in the horizontal platform of the tower, which is limited by the balustrade. The latter area is most affected by growth of vascular plants (e.g. berry bushes) and the blackish colouring affects the stone. XRD analysis of the sample taken from this area (Lu-6) did not show the presence of salts, necessary for the formation of black crust (Pozo-Antonio et al. 2019). The development of vascular plants in the tower area (Fig. 10), as in the west façade (Fig. 7d), favours the mechanical breakage of the granite, either by development of microfractures, or by the joint with the fixing mortar between the granite

The other major deterioration is scaling. It affects mainly the west side of the sanctuary (Fig. 7d, e). This scaling on the granites can be caused by several factors acting synergistically (Freire Lista and Fort 2016). These factors include the presence of salts, such as calcium sulphate (Silva Hermo et al. 2010), the combination of hygric or hydric swelling and thermal dilatation processes (Siegesmund and Dürrast 2014) or by petrophysical factors including total porosity change, capillary water absorption kinetics, evaporation kinetics, air permeability and water vapour conductivity (Bromblet et al. 1996). Although no salts were directly reported in scale sample Lu-4, an increase in calcium and magnesium and LOI was observed in the chemical analysis (Table 3), which may be indicative of the presence of calcium and magnesium salts (such as gypsum, epsomite or nesquehonite), as observed in samples Lu-7, Lu-9 and Lu-10, effloresces from the interior of the building. The preferential development of scales in the western part of the sanctuary can be due to the climatic characteristics of the area. In this region of Spain, the predominant wind gusts are from the NNE, W and S directions, with those from the west reaching speeds over 60 km/h, especially during the winter season (Martí Ezpeleta et al. 1998).

The climatic characteristics of the area where the Tuiza sanctuary is located mean that the building is exposed to wind, rain and freeze–thaw actions. These, together with the leaking from the base of the bell tower, mean that the northern and western parts of the sanctuary are the areas most affected (both the exterior façade and the interior of the building). The most important deterioration problems are those generated by humidity, both from the continuous watering of the lawn and from the discharge of water from the bell tower platform. Our advice is to stop, or at least move the irrigation system several metres away from the building, making sure that the sprinklers do not reach the façade, and to build a perimetral margin of, at least, 0.5 m around the building to prevent the growth of grass and/or other plants, filling it with gravel material that allows for breathing at the base of the building. These actions will allow the evacuation of moisture from the base through the area in contact with the ground. It is also advisable to waterproof the platform of the bell tower, as well as the water drains, such as the gargoyles, allowing the expulsion of excess water from the upper roofs, and preventing the leakage through the roofs and façade, clearing away biological activity.

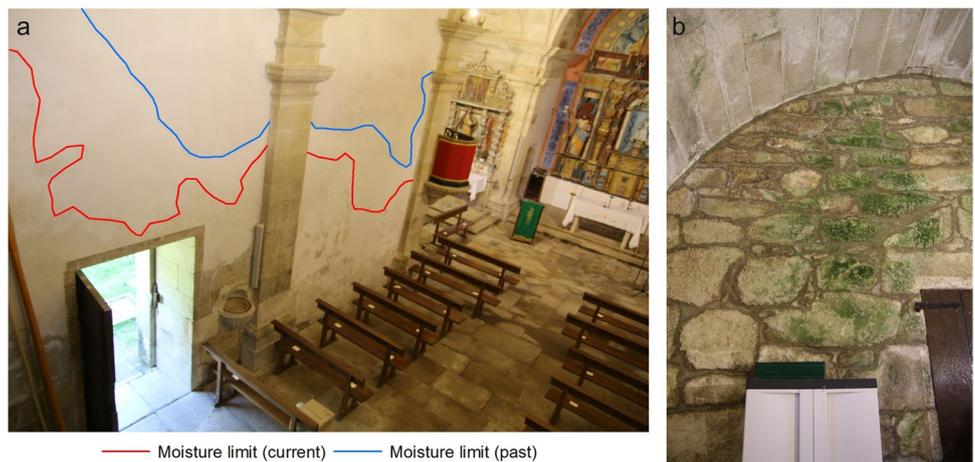
of the building, there is a complete green covering due to biological colonisation (Fig. 8b), affecting more evidently the mortar between the stone blocks. The ceiling in that area is also affected, although to a lesser extent. Efflorescences composed of magnesium carbonates and calcium and magnesium sulphates are observed (Lu-7, Table 2).

Fig. 8 **a** Moisture advance on the walls of the north side of the building. **b** Biological colonisation on the wall of the west side of the building, which gives access to the bell tower staircase

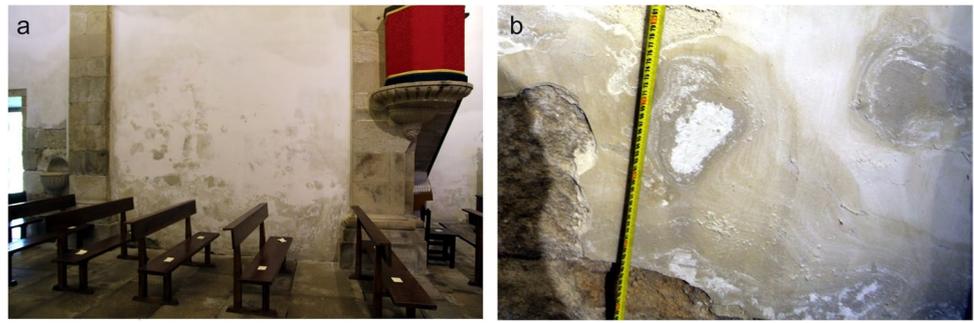
Inside the sanctuary, the main alteration on the ground floor is due to the infiltration of water by capillarity from the base, which has generated efflorescence and sub-efflorescence

processes, mainly composed of gypsum (Lu-9 and Lu-10, Table 2). This is especially evident in the product (apparently a kind of mortar) covering the north and south walls of the building. On the north side, the moisture front has reached more than 3 m in height in the past (Fig. 8a). In the areas where no plaster covering was added, dampness is lower and the height of moisture reaches only up to 40 cm, although some efflorescence is also detectable.

Fig. 9 **a** Humidity stains on the north wall inside the sanctuary. **b** Efflorescence formed in the coating mortar

With regard to the interior of the sanctuary, the high humidity is due to increased capillarity and water retention by the mortar covering the stone. To allow the building to dry out, or at least to diminish dampness, we advise to remove the coating mortar and leave the stone bare. Likewise, it would be advisable to install dehumidifiers to remove the current humidity and ventilate the space effectively since some windows are permanently closed or even blocked with wooden panels.

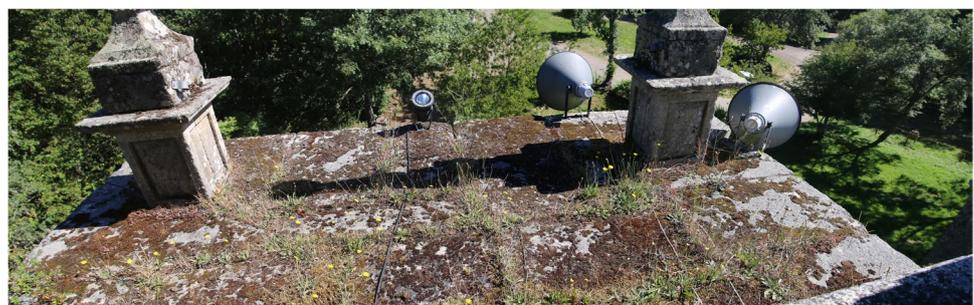
Fig. 10 View of the biological colonisation on the upper platform of the bell tower
