Title: Impact of 8th October 2005 Earthquake Associated with Kashmir

Boundary Thrust (KBT), Pakistan

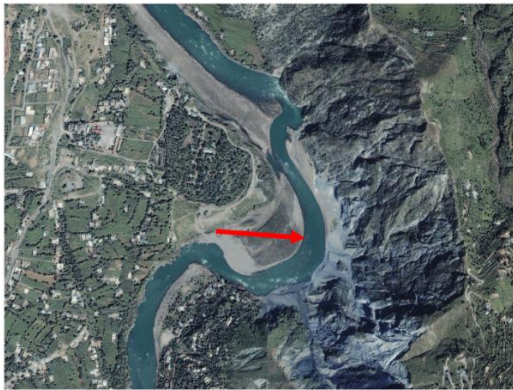
The Ikonos satellite captured an image of a landslide (© 2016 DigitalGlobe)

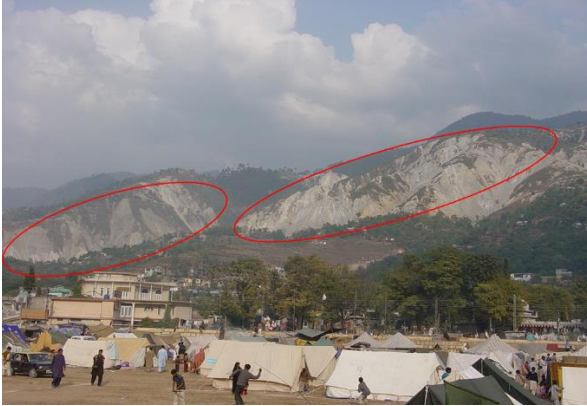
Active fault zone passing north of Muzaffarabad city

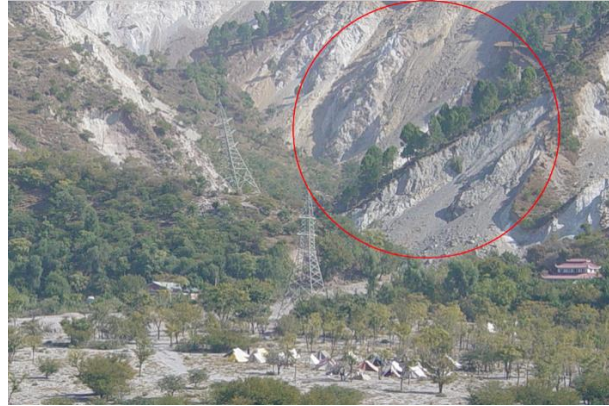
Rock sliding along a fault zone in Balakot area

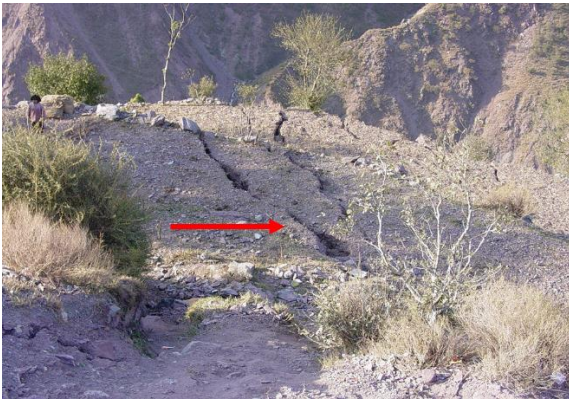
Rock Fracturing on Balakot-Kaghan roadside

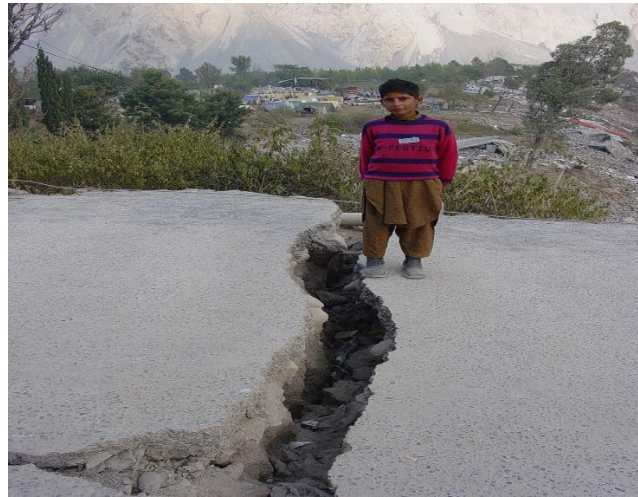
Rupture zone passing through Nisar Camp and the road site

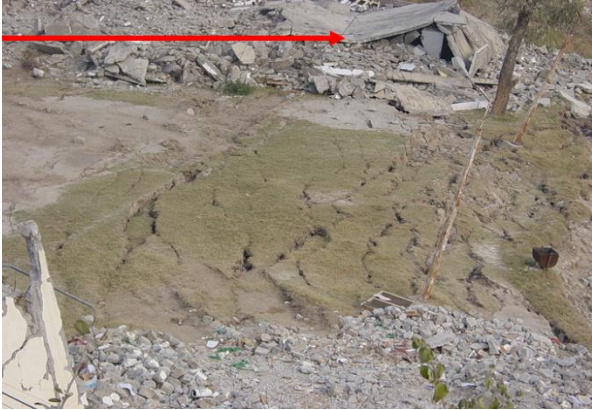
Destroyed Nisar Camp near Muzaffarabad close to rupturing zone

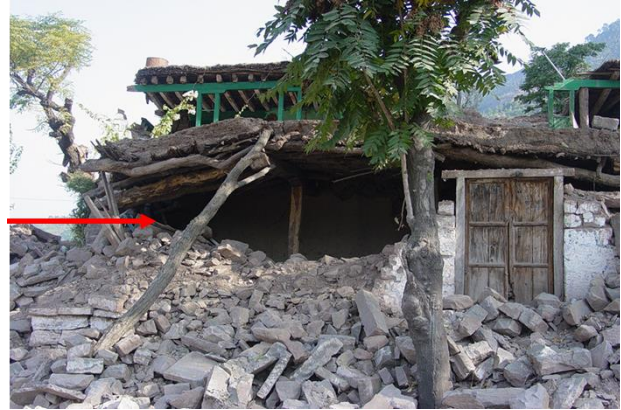
The lightweight wooden house proved earthquake-resistant compared to that constructed with blocks and improper shaped rock pieces-Dhirkot

The Structures that Survived: Properly sited light all-wood structures/houses, and especially those with light slanting wood roofs, survived very well. There were very few casualties of the inmates. Concrete framework structured buildings with proper foundations survived very well. Some public utility buildings built, by International Organizations, NGOs, considering the seismic requirements of the area survived almost intact.

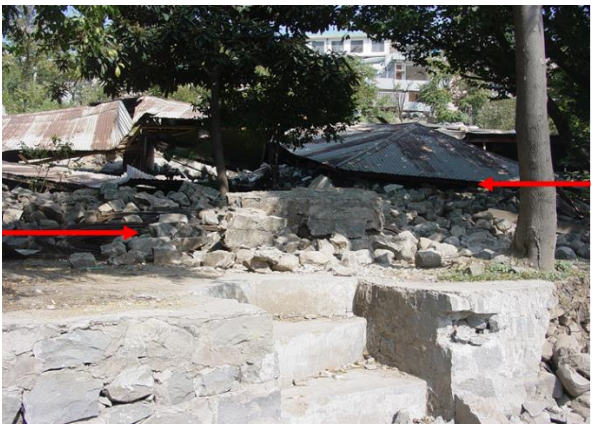
Buildings constructed using cobbles and lean mortar suffer maximum damage –Bagh AJK

Causes of Colossal Loss of Life and Property: In rural areas, the collapse of mud houses during the earthquake resulted in injuries and suffocation of the inmates. In villages and towns a large number of houses with walls built using rounded to subrounded cobbles (from nearby streams/terraces) and lean cement or mud paste collapsed like proverbial ‘house of cards’ killing or seriously injuring inmates in large numbers. A large number of these cobble lean paste/mud paste walled houses had heavy reinforced concrete roofs (lanter, which were built after people from AJK went to Middle East for Jobs). These roof slabs either killed or trapped inmates, many of whom died because they could not be rescued immediately due to lack of equipment (cranes, lifters, and reinforced concrete cutters). High-level terraces slumped and slides on peripheries resulting in the collapse and tumbling of houses. A large number of hamlets built on steep artificially terraced slopes were destroyed or buried due to extensive land sliding triggered by the earthquake. The inmates suffered very heavy casualties. The buildings, no matter how well built but sited on Kashmir Boundary Thrust active rupture zone, were destroyed.

- Cobble-lean paste, mud paste structures, responsible for a large number of deaths, should be disallowed.
- Depending upon economic conditions, the following types of structures may be encouraged.
- Raft foundation combined with light wooden structure with fireproof treatment on the inside.
- Reinforced concrete frame structure with appropriate foundation design.
- Structures with raft foundation and a brick-mortar structure with reinforced concrete horizontal bands at plinth level, above doors/windows, and a reinforced concrete roof should be encouraged. The horizontal bands should be tied vertically to produce a braced structure.

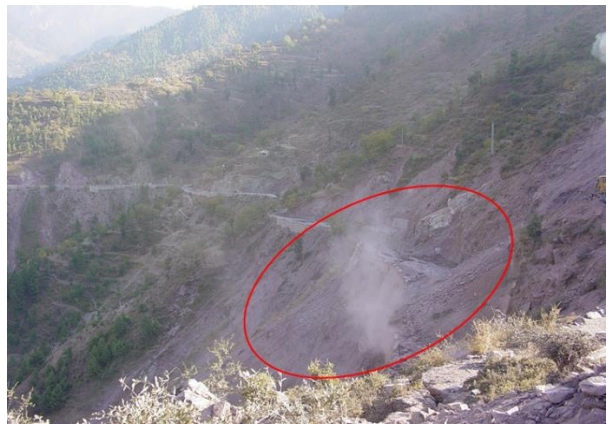
Fracturing and shaking caused major slides along the Kaghan road

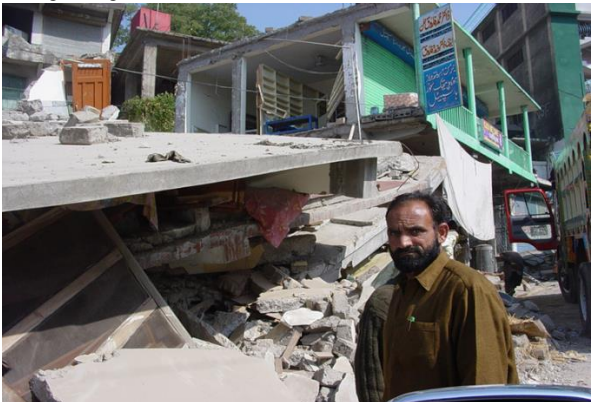
Collapsed improper concrete buildings in the foreground and light wooden structures in the background

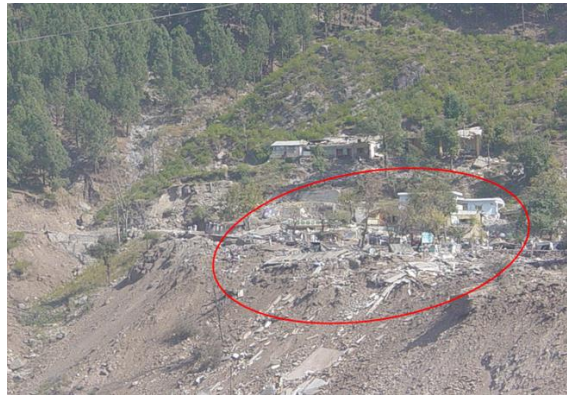
Slope failure caused damage to many buildings in Balakot

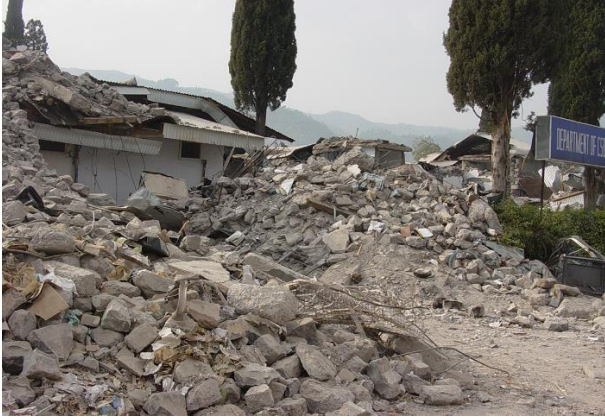
Devastated Old Campus of AJK University, Muzaffarabad

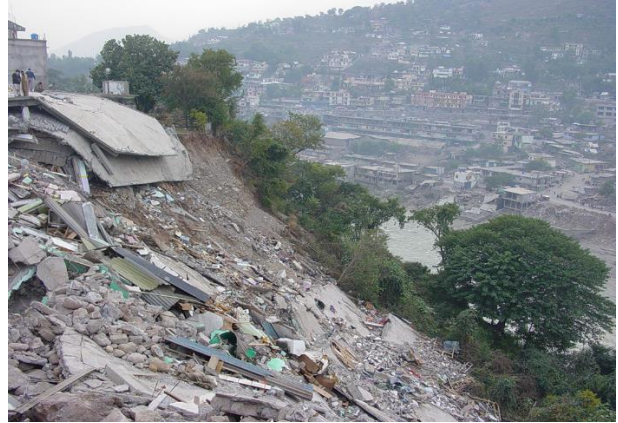
Slope/ soil failure in Muzaffarabad along with the River Neelum
