1 Widespread Wood Placement and Regrading Drive Lateral Connectivity  
2 and Reworking of the Channel and Floodplain in a Valley Bottom Reset  
3 to Stage 0

4 Daniel N. Scott, PhD<sup>1</sup>

5 <sup>1</sup>Colorado State University, Department of Geosciences; dan.scott@colostate.edu

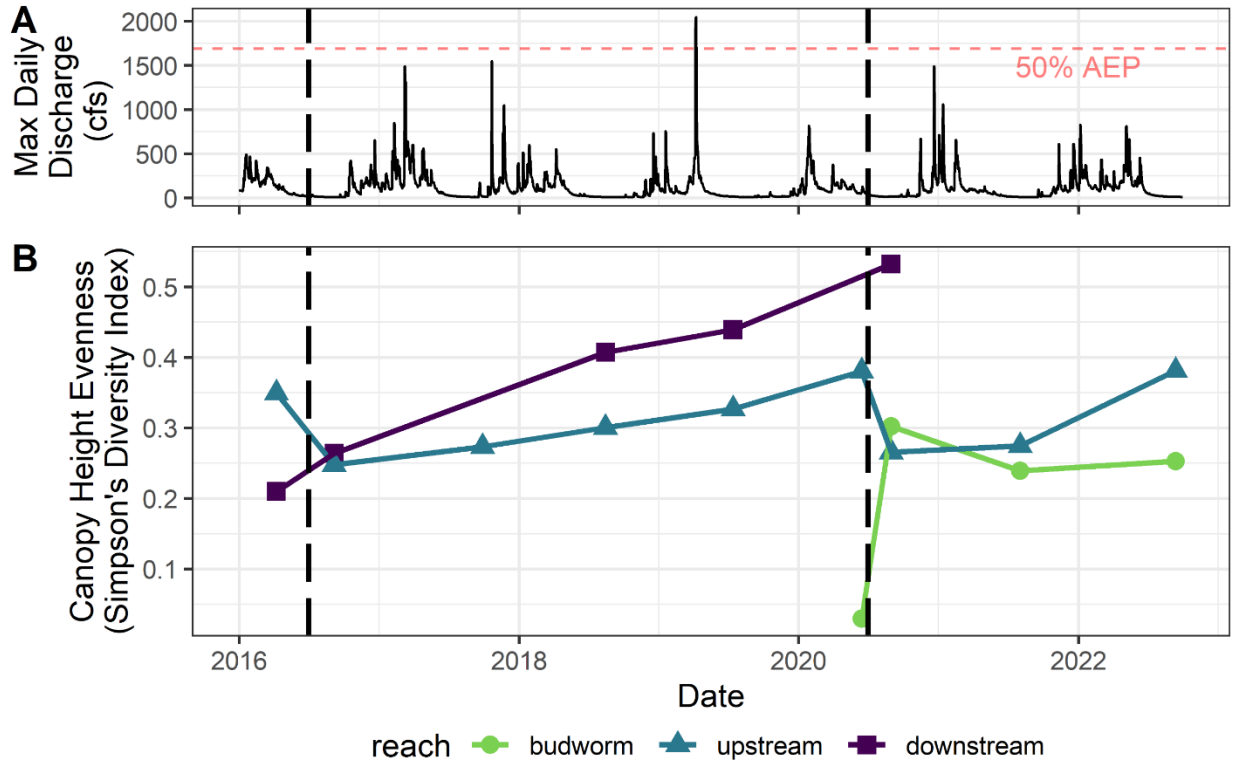
**Figure 6: Estimated flow history (from Lookout Creek) (A), and evenness of vegetation canopy height across the valley bottom through time (B). Dashed lines indicate phases 1 and 2 of restoration.**

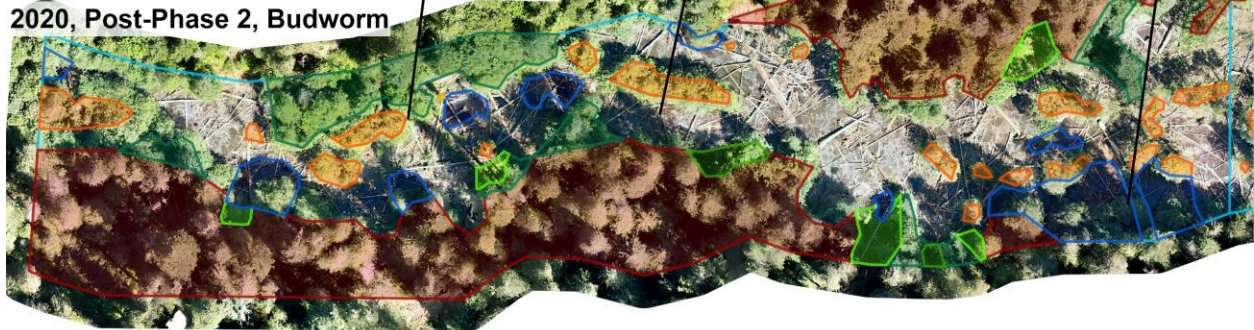
large wood lattice covers most of channel

channel fill diverts flow down relict side channels and reconnects floodplain

large pools remain where channel was not infilled

overbank flow carves new channels through floodplain

newly formed jams divert flow into floodplain and terrace, carving new channels

wood substantially aggregates, forming jams

newly formed jams backwater and plunge converting floodplain to flow, forming new pools channel

320 Wood rearrangement in the channel along with the significant regrading done in phase 2 drove  
321 substantial floodplain inundation and reworking. Lateral hydrologic and sediment connectivity were  
322 indicated by overbank sand deposition, leaves and sticks raked on living vegetation, channel incision  
323 into formerly unchanneled floodplain (See Supplemental Section S3), scour and deposition on the  
324 floodplain, and nascent channels incised into floodplain and even terrace surfaces (Figure 10, Figure 11).

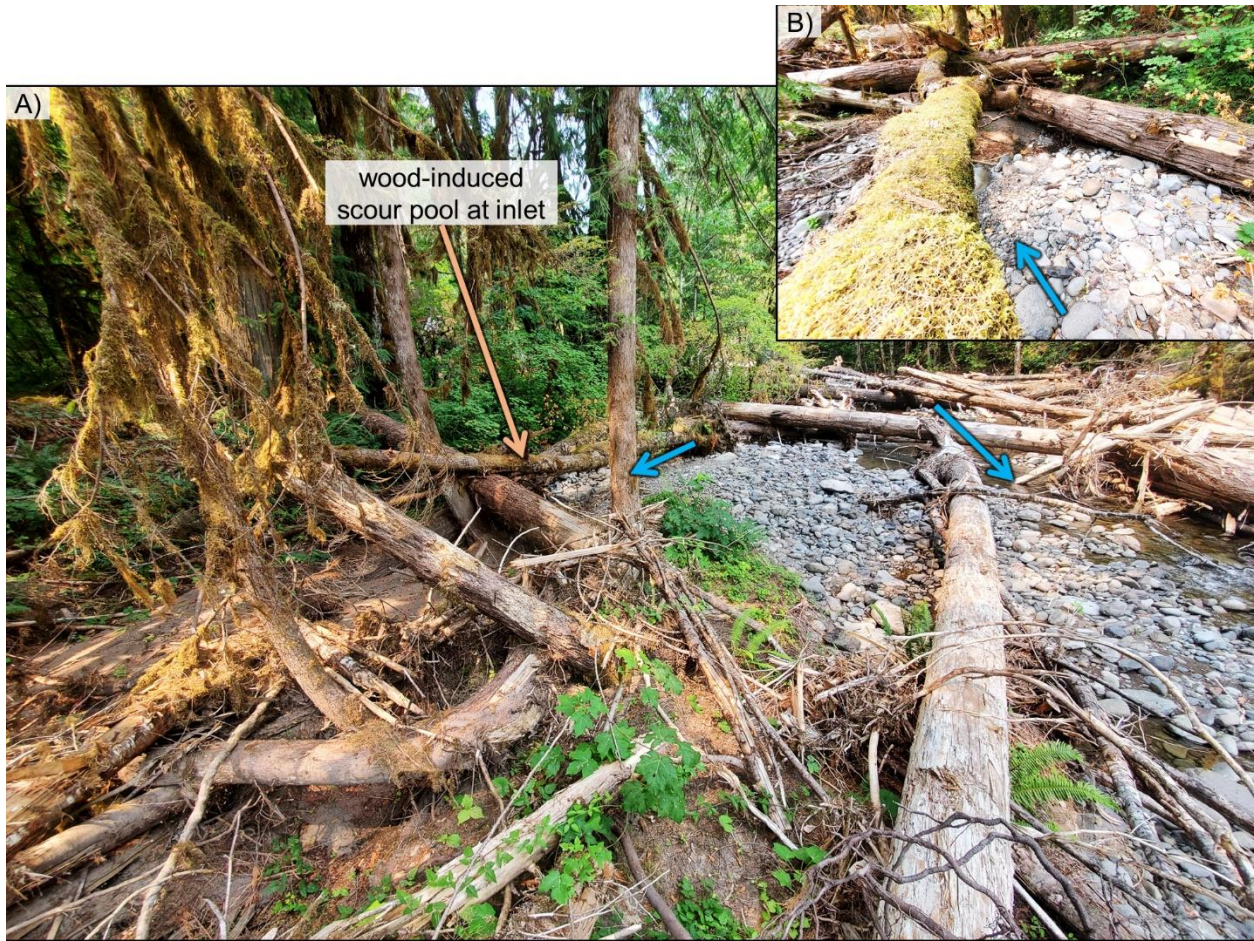
333 **Figure 12: Picture looking upstream (A) at a newly formed side channel branching off into the floodplain on right**  
334 **river (left side of picture) and downstream at that same side channel's inlet (B) (August 3, 2021). Blue arrows**  
335 **show flow directions.**

396 conveyance (Figure 12). Importantly, these floodplain wood jams were dominantly formed by small  
397 wood < 10cm in diameter and < 1m in length (although small wood occasionally racked on larger logs  
398 protruding into floodplain forests). Such small wood also racked on and filled in in-channel wood jams,  
399 likely reducing their porosity (Livers et al., 2020; Spreitzer et al., 2020) and thus increasing their ability to  
400 divert flow into the overbank.

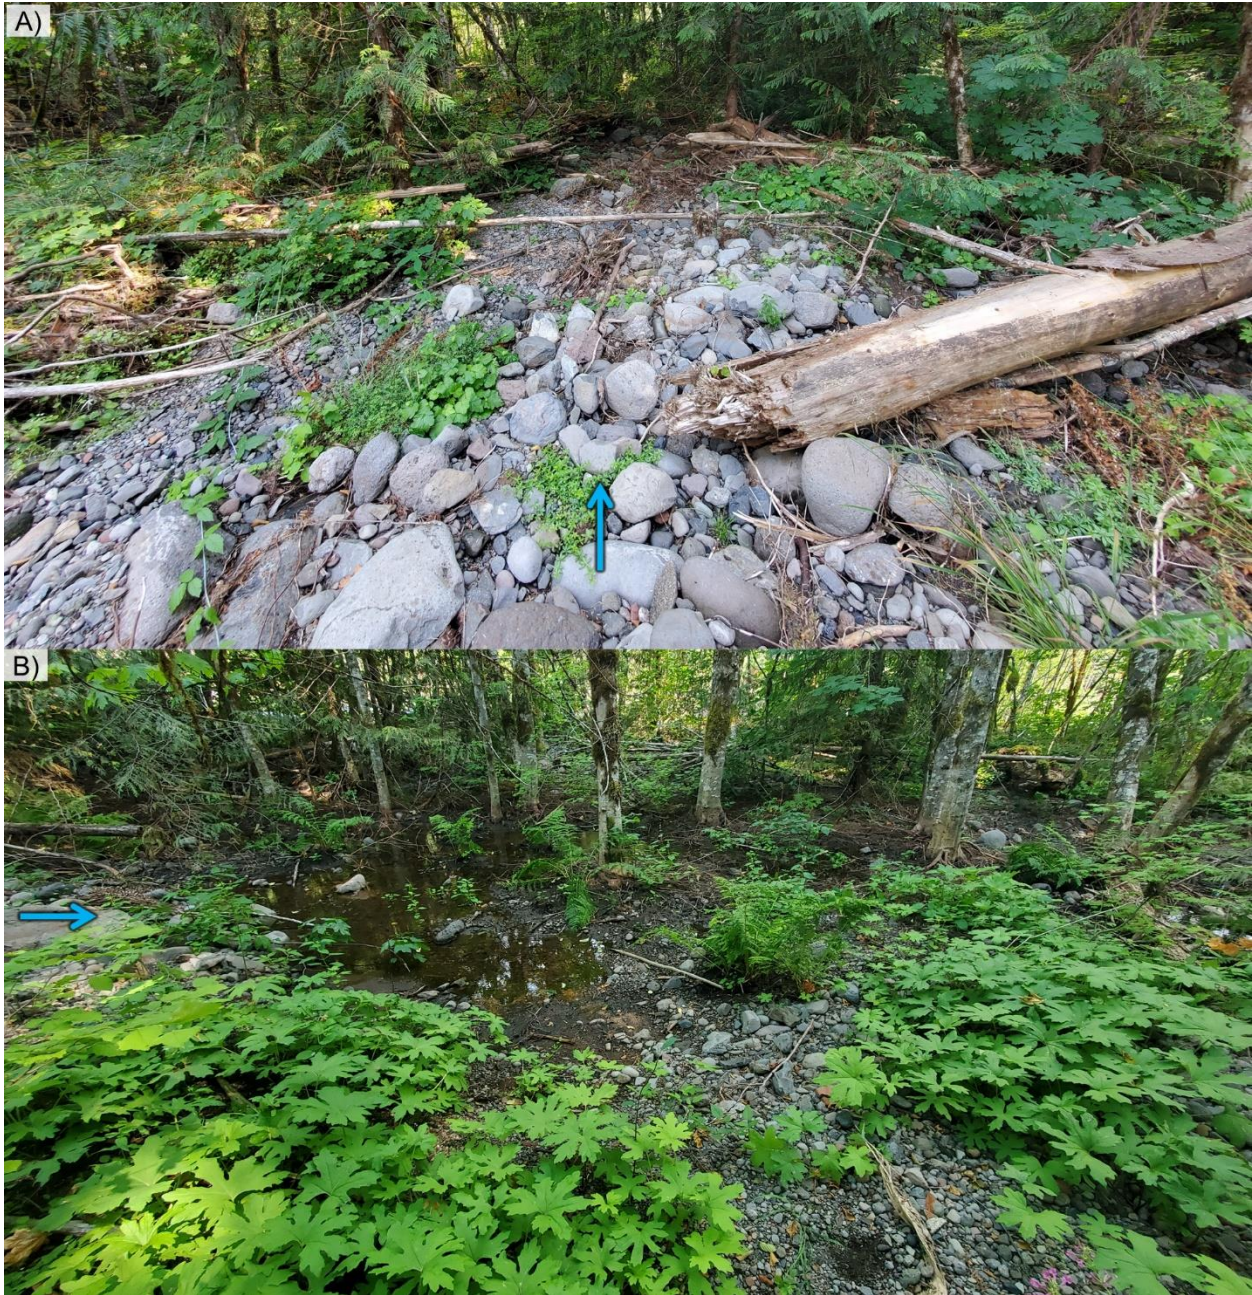
338 **Figure 13: Picture looking downstream at a channel inlet newly carved into a former floodplain surface (A) and,**  
339 **just downstream of that inlet, looking left at a low flow wetted area scoured into what was formerly a fully**  
340 **vegetated floodplain surface (B) (August 2, 2021). Arrows show flow direction.**

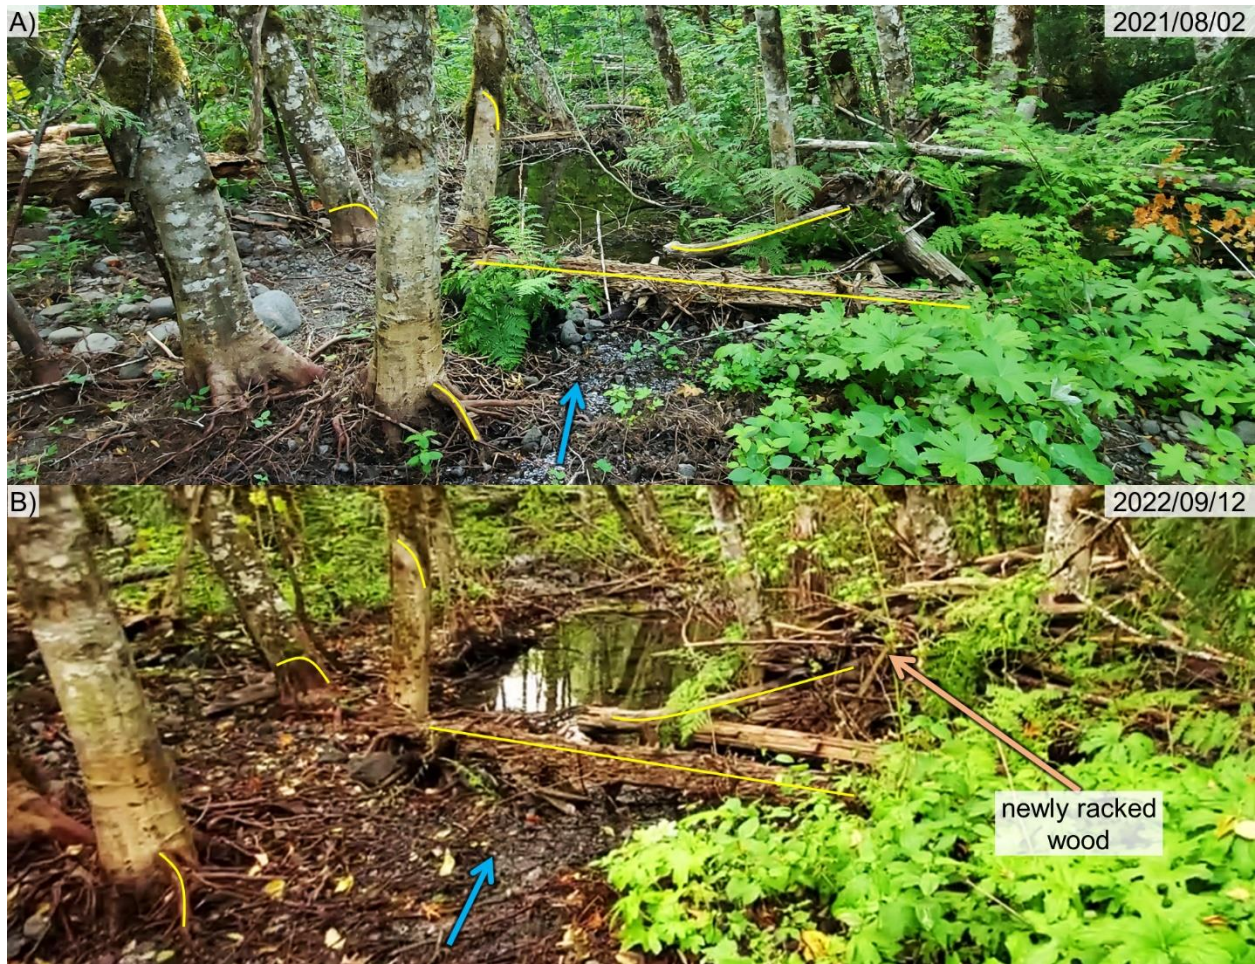
355 **Figure 14: Repeat photos from 1 year (A) and 2 years (B). after phase 2 implementation, showing newly racked**  
 356 **wood in a new low flow channel created during the December 2020 flood. Yellow lines highlight similar features**  
 357 **to reference the two photos.**

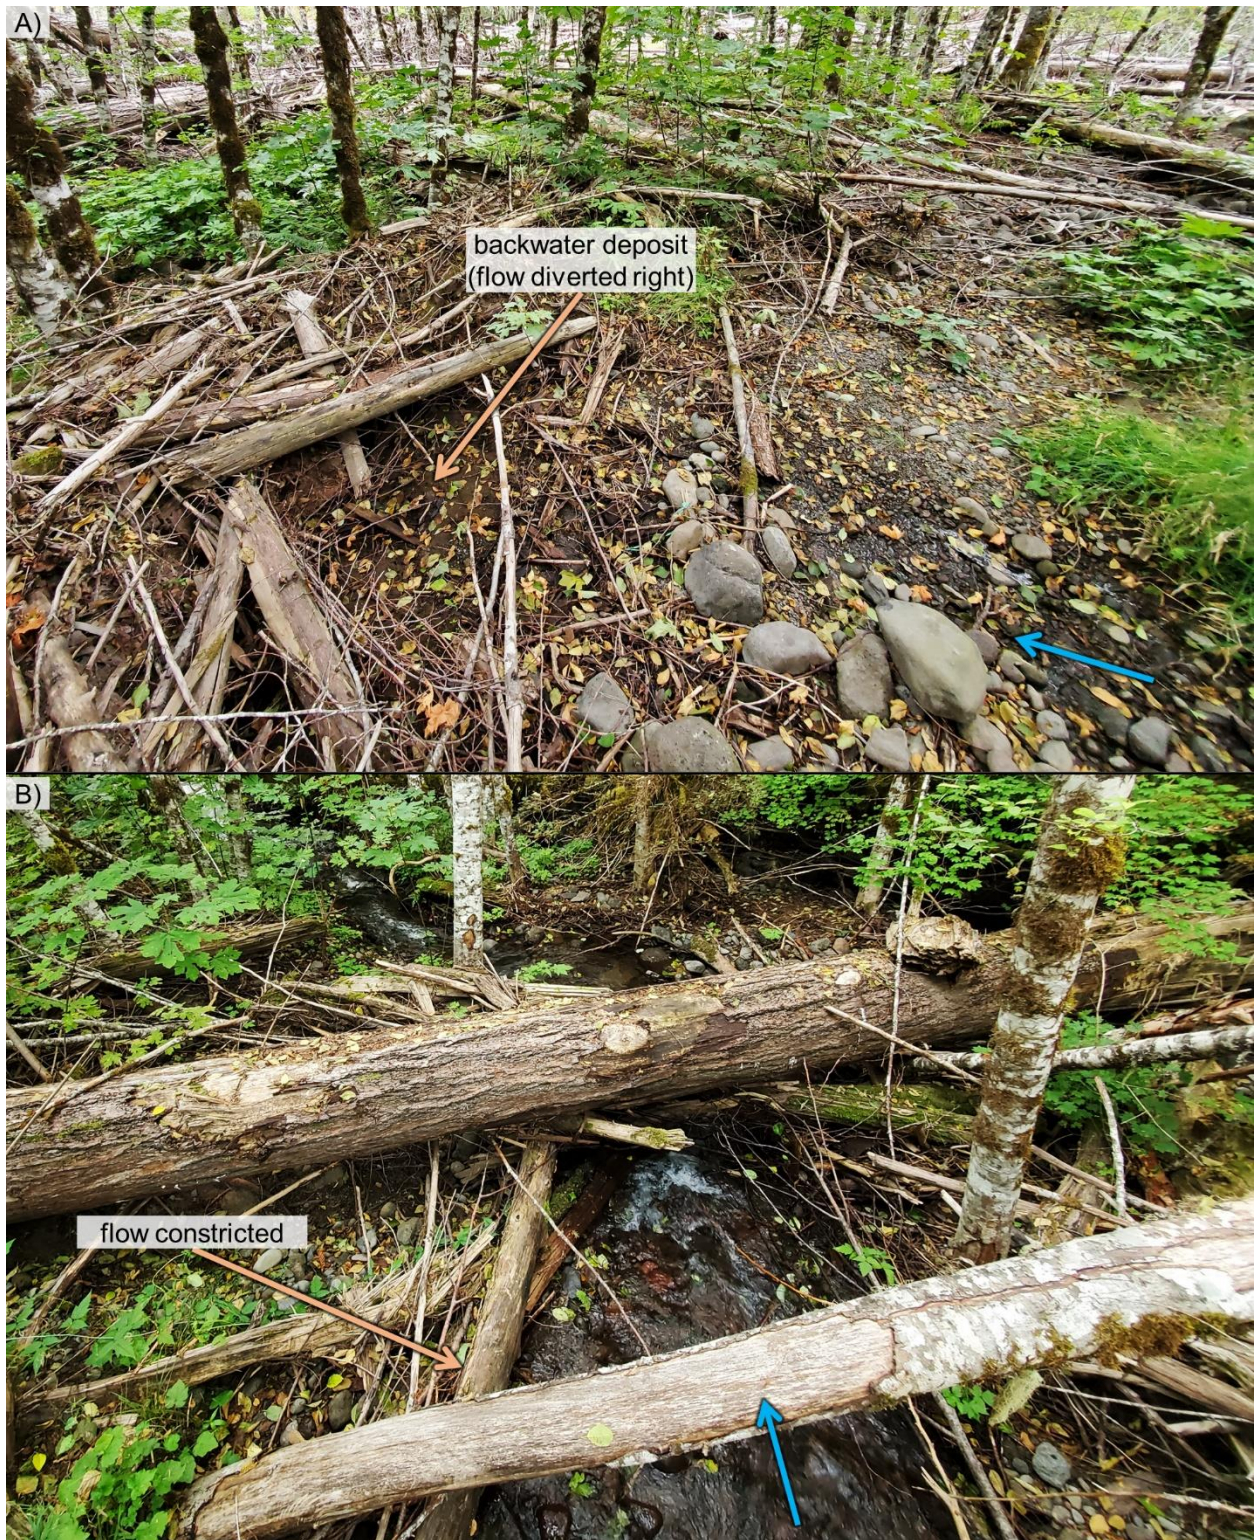
402 Figure 15: Pictures of wood accumulations in forested floodplain channels that are backwatering (A) and
