Title: Stones that Tell Stories

Abstract

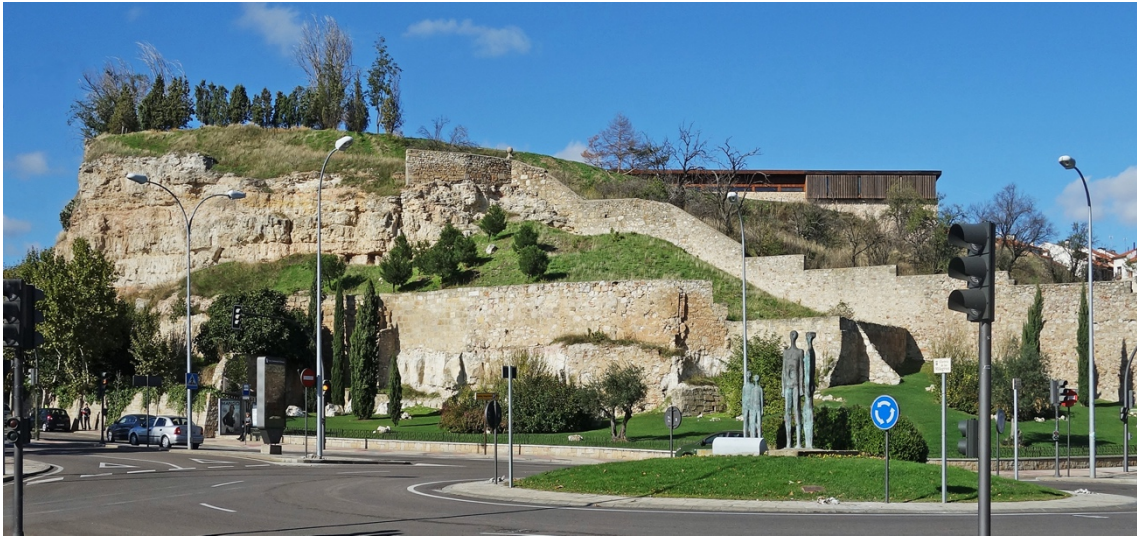
Figure 1. Cerro de San Vicente. A hill of opal-cemented conglomerate, the origin of the city and today's southern entrance to the city. Picture courtesy of Vicente Sierra Puparelli.

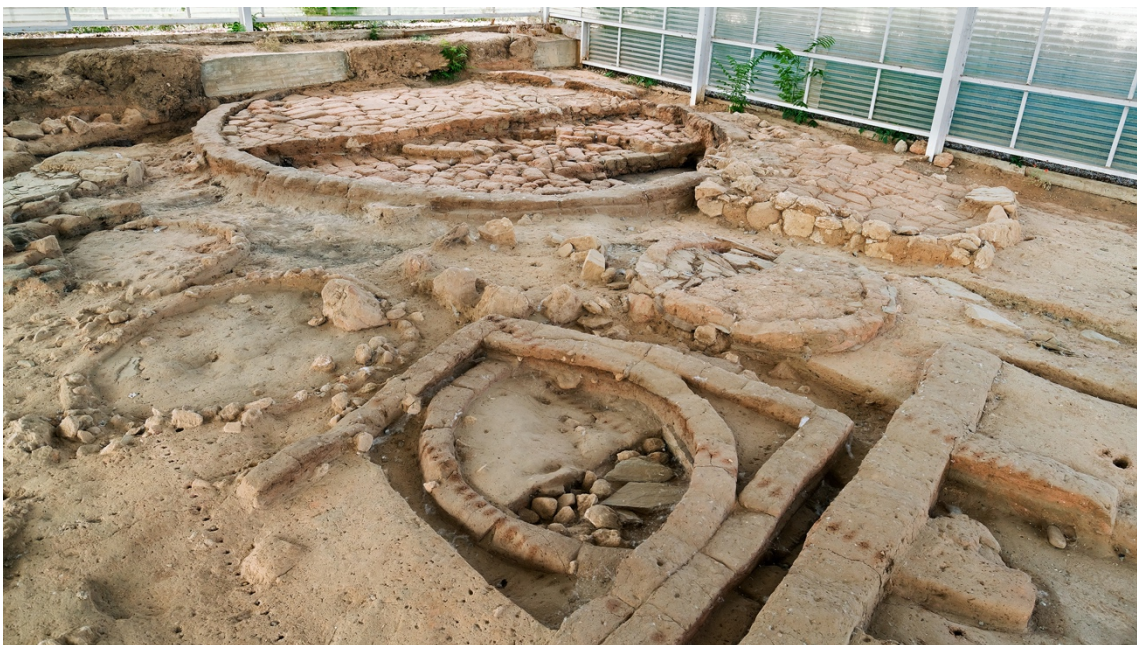
Figure 2. Archaeological excavations at Cerro de San Vicente, where a complex settlement structure was the origin of the city of Salamanca. Picture courtesy of Vicente Sierra Puparelli.

to defend the location that would become their permanent dwellings (Figure 2) (Pereira 2019 and references therein).

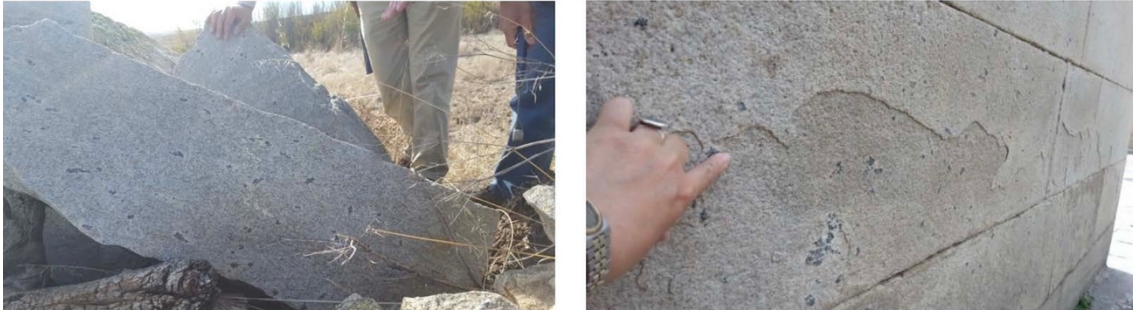
Figure 3. Left: Slab of Martinamor granite in the historical quarry. Right: Martinamor granite in the basal part of a historic building of Salamanca. Scaling in granite is common but does not affect its integrity. Explanation in Pereira 2019.

years of dictatorship, but also democratic republics and many different periods of monarchies, under the House of Bourbon. The transitions between them were never smooth, and one of them led to the bloodiest and most unfair civil war in 1936-1939. More than 500,000 people were killed during this war. Some bodies are still to be found in unknown areas along the roads. Spain was “neutral” during the Second World War, from 1939 onwards, mainly because it was exhausted after the massacre of citizens during its civil war. However, the dictator Franco was indebted to the dictator Hitler for the help he had given him during the civil war to devastate parts of Spain that were unwilling to succumb to the dictatorship. Such was the case in Gernika, in the Basque Country, northern Spain (now declared the First Site of Democratic Memory by the Spanish Government: (https://www.boe.es/diario_boe/txt.php?id=BOE-A-2023-10202. Last accessed 4 June 2023)). Favors had to be repaid, and the Spanish dictatorship helped the fascist German government through the preferential sale of tungsten, indispensable for building more cannons to continue the war. The province of Salamanca was one of the main producers of tungsten, together with other areas in western Iberia, including Portugal. The province of Salamanca experienced active mining of tungsten, tin, and copper during and after the Second World War. The price of tungsten was very high, even higher than that of gold, because the Germans needed it for tungsten carbide tools and armor-piercing ammunition, among other things. The allies tried to prevent them from buying tungsten, which was extracted from various mines in Spain and Portugal, by buying it themselves at a better price, so that its value increased dramatically. Tungsten mining in this area was closed down in the 1970s due to falling prices. However, the landscape is full of abandoned mines which are part of the cultural heritage and are linked to a Point of Geological Interest (San Pelayo Orthogneiss, Spanish Geological Service (IGME), 2018). Tungsten brought such benefits to the families that many of them started very basic artisanal excavations all over the place. When the tungsten economy ceased, the excavations were abandoned, and the remains can be found all over the countryside. They are witnesses of a prosperous society in the past and could be used as mining/industrial heritage of the area, although there has been no interest in such communication and outreach activity. The tungsten enrichment was closely related to the tourmaline leucogranite, affected by late Hercynian fluids (Pesquera et al. 2005) that had been quarried for many centuries to build the architectural heritage of the city of Salamanca and its surroundings (Pereira and Cooper 2013; Pereira 2019; Pereira et al. 2014) (Figure 3).

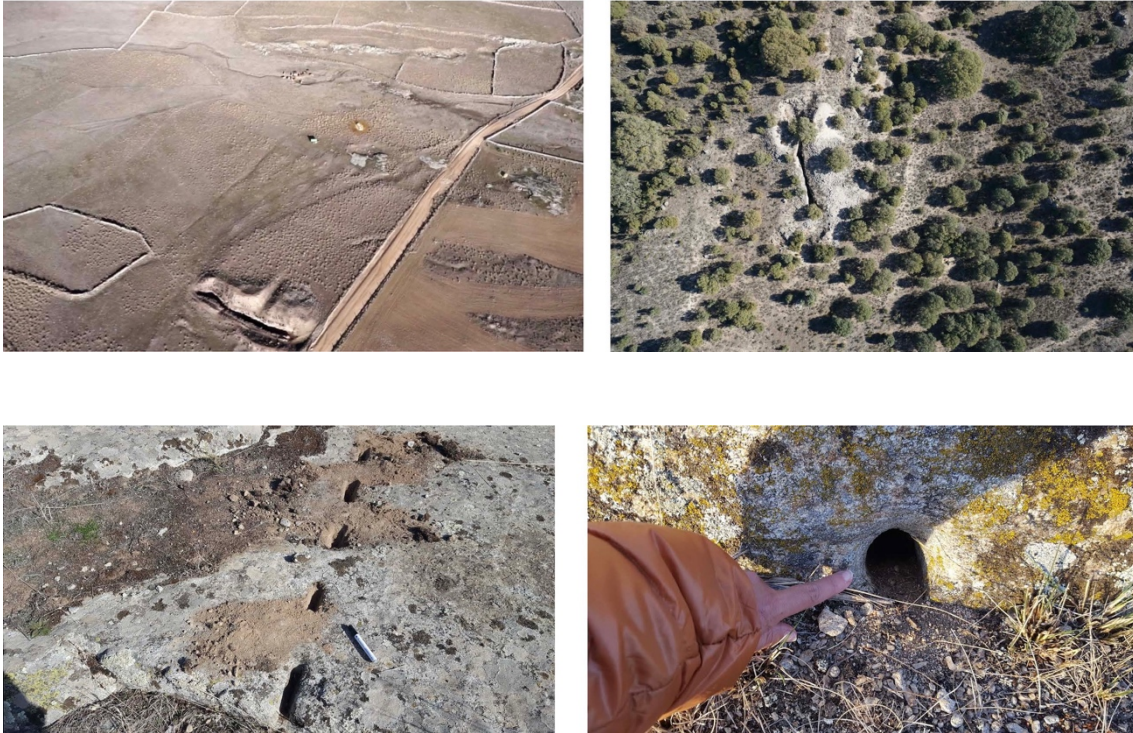
Figure 4. Above: Drone images of an abandoned artisanal tungsten mine in Salamanca province. Below: Ancient quarrying marks on Martinamor granite.

The use of this granite had been proven to be an excellent material for the preservation of historic buildings. In fact, after the Lisbon earthquake of 1755, in which massive destruction occurred in Portugal, but also in Spain, prominent architects of the time (e.g., Juan de Sagarvinaga, Juan de Alava, Juan Gómez de Mora, Alonso de Covarruvias, and others) insisted on reinforcing the buildings affected by the earthquake only with the ‘good Martinamor granite’. Such was the case of the New Cathedral of Salamanca (built between 16th and 18th centuries; Portal Monge 1988), which today maintains its majesty, although it is leaning as a result of the earthquake. The historic granite quarry closed down a long time ago and the use of good granite was replaced by other granites that were, and are, easier to transport to the city and other areas. However, the old quarry preserves some vestiges of earlier quarrying methods, which are similar to those observed in ancient Egypt and prehistoric sites in Europe and South America (Sousa et al. 2019 and references therein) (Figure 4). A study has recently been carried out on the fracturing pattern of the Martinamor granite in outcrops of the historic quarry to assess the possibility of supplying material for the restoration of heritage monuments (Sousa et al. 2019). From the results it was concluded that only small blocks can be obtained for restoration; therefore, the outcrops should be protected for such purposes. As a reflection, the area of outcrops and ancient quarries, as well as that of mining activities found in the same location, should be preserved as examples of historical extraction techniques and as a remembrance of our geological-materials-based society. Proposals have been suggested for the geoconservation of the site (Figure 4) (Sousa et al. 2019)

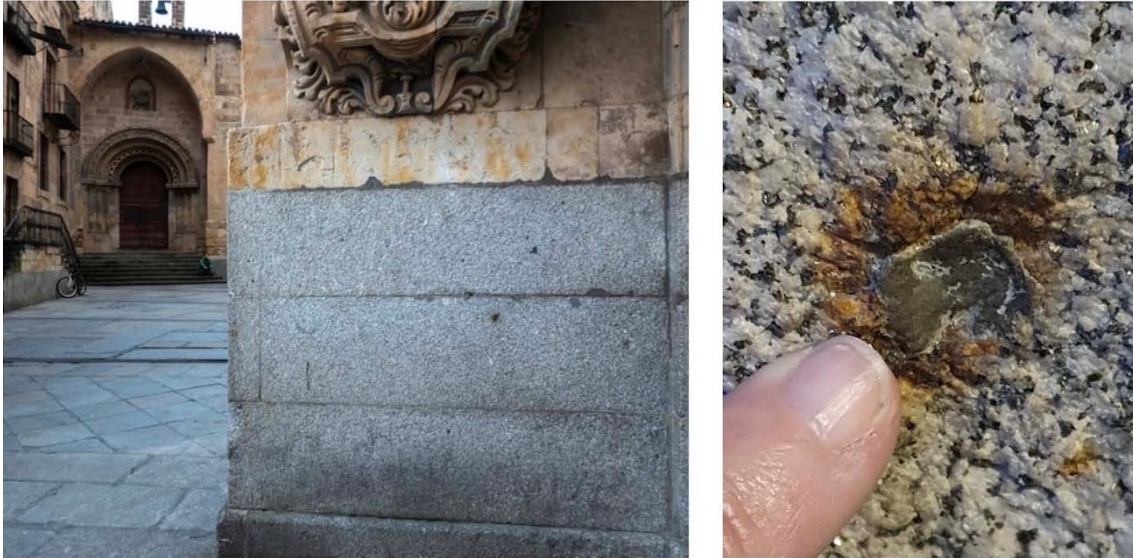
Figure 5. Dark spots in granite, due to small iron-rich enclaves, which were interpreted as marks left by the shooting. Even if the explanation is not true, history allows us to recall a very tragic event at the beginning of the war. Picture courtesy of Vicente Sierra Puparelli. Right: Detail of one of the dark spots. Picture by the author.

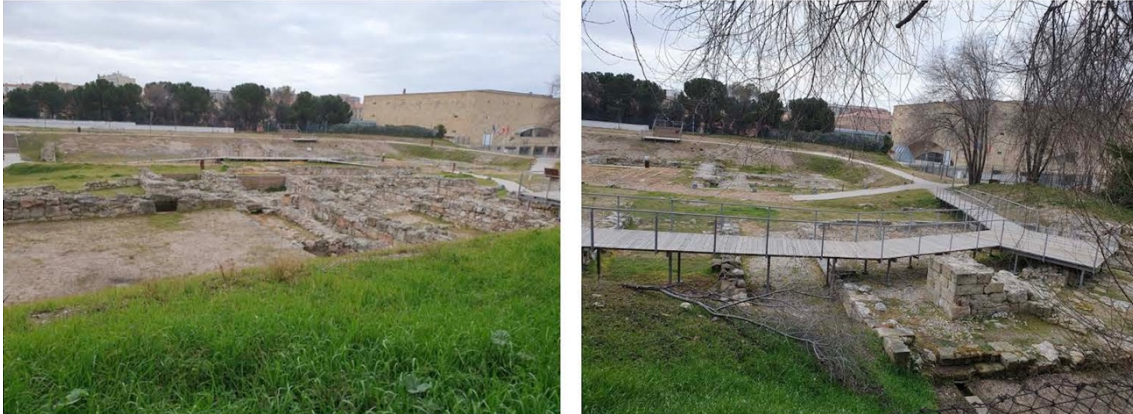
Figure 8. Remains of a convent and two university residences, which were demolished by Napoleon's troops. Pictures by the author.

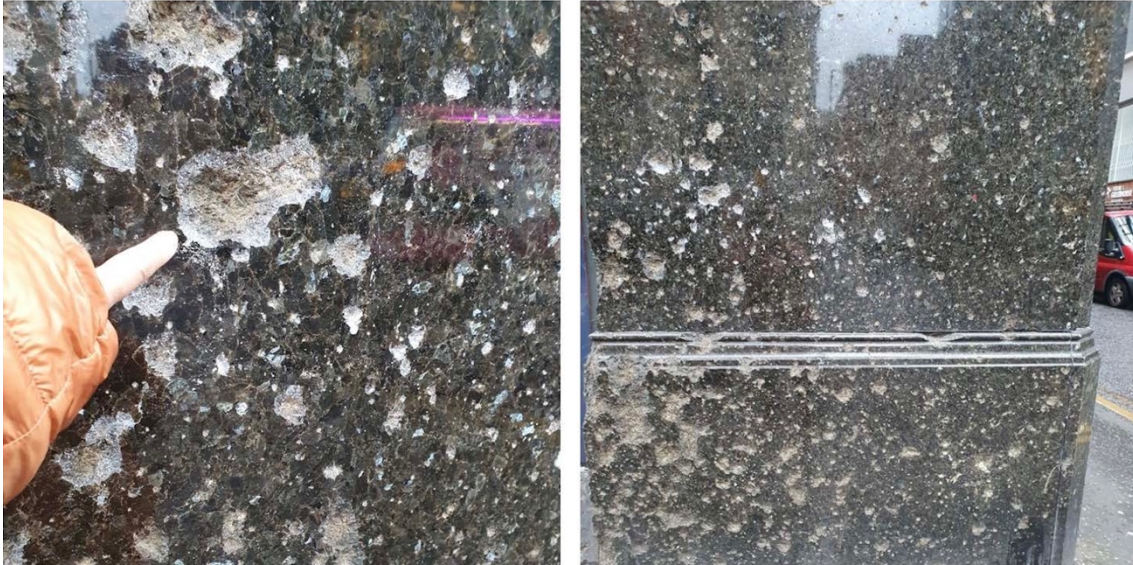
Figure 10. Bullet marks on a building façade in the center of Belfast. From the texture and observation of the stone, a syenite can be recognized. Picture by the author

walls and façades of buildings in cities, mainly in Belfast. One striking feature that remains, and which in the author's opinion should be preserved, maintained, and explained on an in-situ plaque, is a wall affected by bullets from an assault rifle during the shootings (Figure 10). The affected wall belongs to a commercial building in one of the central streets of Belfast. The stone is a nepheline syenite, and the texture of this rock can still be determined to identify the lithology. At the mesoscopic scale, bluish and whitish crystals of potassium feldspars can be distinguished in a mafic matrix in which biotite flakes can also be distinguished. After searching for such a rock in Great Britain, the author found the most plausible option: the "borolanite" from the Aultivullin quarry in the Loch Borralan region of North-Western Scotland. This quarry is no longer in use, but the stones have been described in several scientific papers (e.g., Stephenson 2000; Gillen 2019; Fox and Searle 2021). The author was unable to find any more shooting marks on buildings in the surrounding area or other areas of Belfast. However, when searching on the Internet for "shooting marks" in the context of the Irish Troubles, she came across a very illustrative picture of a woman firing a rifle in a corner where the stone covering the building is very different, probably sandstone, as in the picture it can be seen that the bullet impacts have a different morphology and the volume of material removed from the damaged block is smaller than in the case of the igneous rock (Campbell et al. 2022a). There is a contrast in the crater morphology caused by projectile impacts depending on the nature of the target stone. For example, bullet impacts in limestone produce wider, deeper, and more voluminous impact craters than the same projectiles in sandstone targets (Campbell et al. 2022b). Whereas bullet impact in granite produces roughly circular depressions within highly crushed target material in the center of the crater, with irregular rims caused by fragments spalling from the target and radial cracks with different lengths along the crater rim (Wang et al. 2020). Bullet impacts seem to depend on the lithology of the target, but also the type of projectile and the weapon used for the shot. Therefore, these marks could be used as a forensic tool to investigate criminal and violent actions and bring them to court, including the International Criminal Court in The Hague to prosecute those accused of war crimes, crimes against humanity, and genocides such as those that are currently taking place in various regions (e.g., Ukraine, Syria, Sudan, etc.). Regarding the case of the Irish Troubles, the picture of the IRA woman is an important record of the conflictive times; it is one of the images in the collection of the Irish press photographer Colman Doyle, archived in the National Library of Ireland (Figure 11). Both the marked stone and the photograph are reminders of a time, not so long ago,
