# **Field and LiDAR data observations of erosion on anthropogenic valley fills and associated landscape produced by mountaintop removal/valley fill coal mining in Central Appalachia**

Miles Reed<sup>1,2\*</sup> and Steve Kite<sup>1</sup>

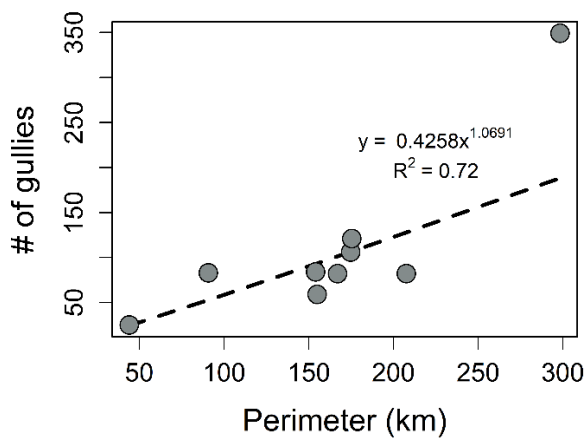
**Figure 10.** Relationship between perimeter of MTR/VF landscape in LiDAR datasets and number of gullies. The outlier (Perry-Knot-Breathitt) had the highest proportion of gullies occurring upon valley fills.

slopes rather than valley fills, an unexpected result. The perimeter of mined landscape explained much of the variance within the total amount of observed gullies ( $R^2 = 0.72$ ,  $p < 0.01$ ) when fit with a power law equation (Fig. 10). The lone outlier is the Perry-Knott-Breathitt (KY), which had the greatest proportion of gullies occurring on valley fills (~25%). Retention cells are analogous to drainage ditches along the edges of roads occurring in steep topography. Previous research has shown that the unnatural concentration of flow from artificially enhanced drainage area in ditches associated with roads can induce gully erosion (Montgomery, 1994; Wemple et al., 2001). Whether gully erosion associated with retention cells observed in the LiDAR datasets was predominantly induced by overtopping or intentional discharge is unknown. As retention cells are designed to attenuate runoff, cumulative failures may counteract the diminished stormflow response associated with the MTR/VF landscape (Zégre et al., 2014; Nippgen et al., 2017). The overtopping of saturated terraces on valley fill faces leading to gully erosion may be analogous to a process observed in areas with abandoned agricultural terraces (Llorens et al., 1992). MTR/VF terraces are designed to slope away from the next outslope and towards the constructed drain. Local disturbances such as bioturbation or freeze-thaw of soil can disrupt the designed drainage pathways, enhancing saturation. The widespread gullying of colluvial slopes below the MTR/VF periphery warrants a new interpretation of the main findings of Fox (2009), which concluded that accelerated biogenic carbon export in MTR/VF affected streams was associated with bank erosion. According to the field and LiDAR data observations, gully erosion of colluvial slopes adjacent to MTR/VF may be the source of the extra carbon.

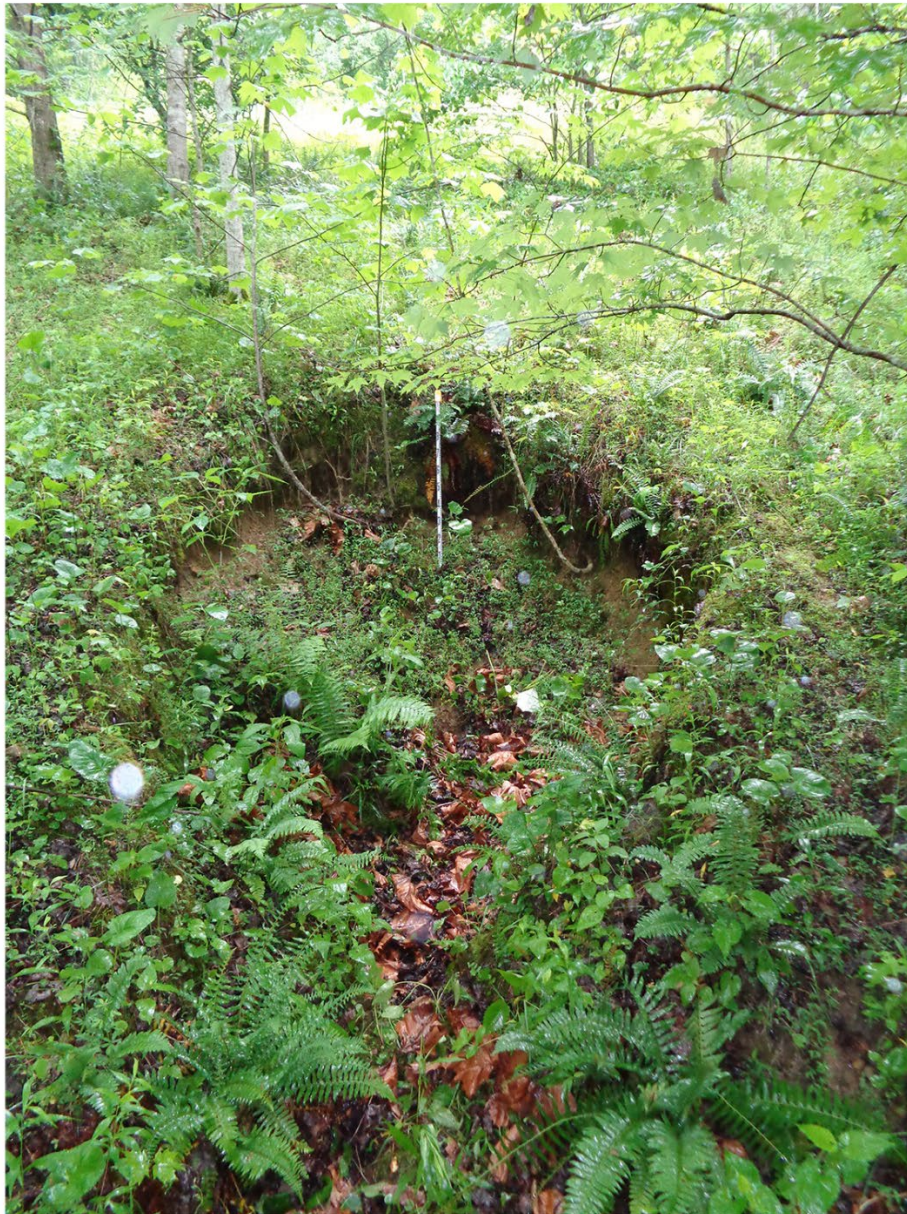
**Supp. Figure 14.** Upslope view of arcuate landform within the valley fill face of Whitman 8 inferred to be caused by seepage. The max width is 2.6 m, and max depth is 1.1 m. The landform is visible in the 2010 LiDAR data, yet remains partially unvegetated, indicating ongoing erosion or adverse hydrological conditions. The landform is located above a non-designed spring in the center of the valley fill. The measuring tape in the center is extended to 1 m.

Erosion induced by seepage occurred in several catchments. The largest example was an arcuate feature in the Whitman 8 catchment with a 2.6 m wide by 1.1 m deep scarp, but no visible upslope flowpath (Supp. Fig 4). Although this feature was seen in the LiDAR data, there was little vegetation present in 2017, indicating active erosion or
