1 **Features of crevasse splay deposits and sedimentary processes associated with**
2 **levee breaching by the October 2019 flood of the Chikuma River, Central Japan**

19 **ABSTRACT**

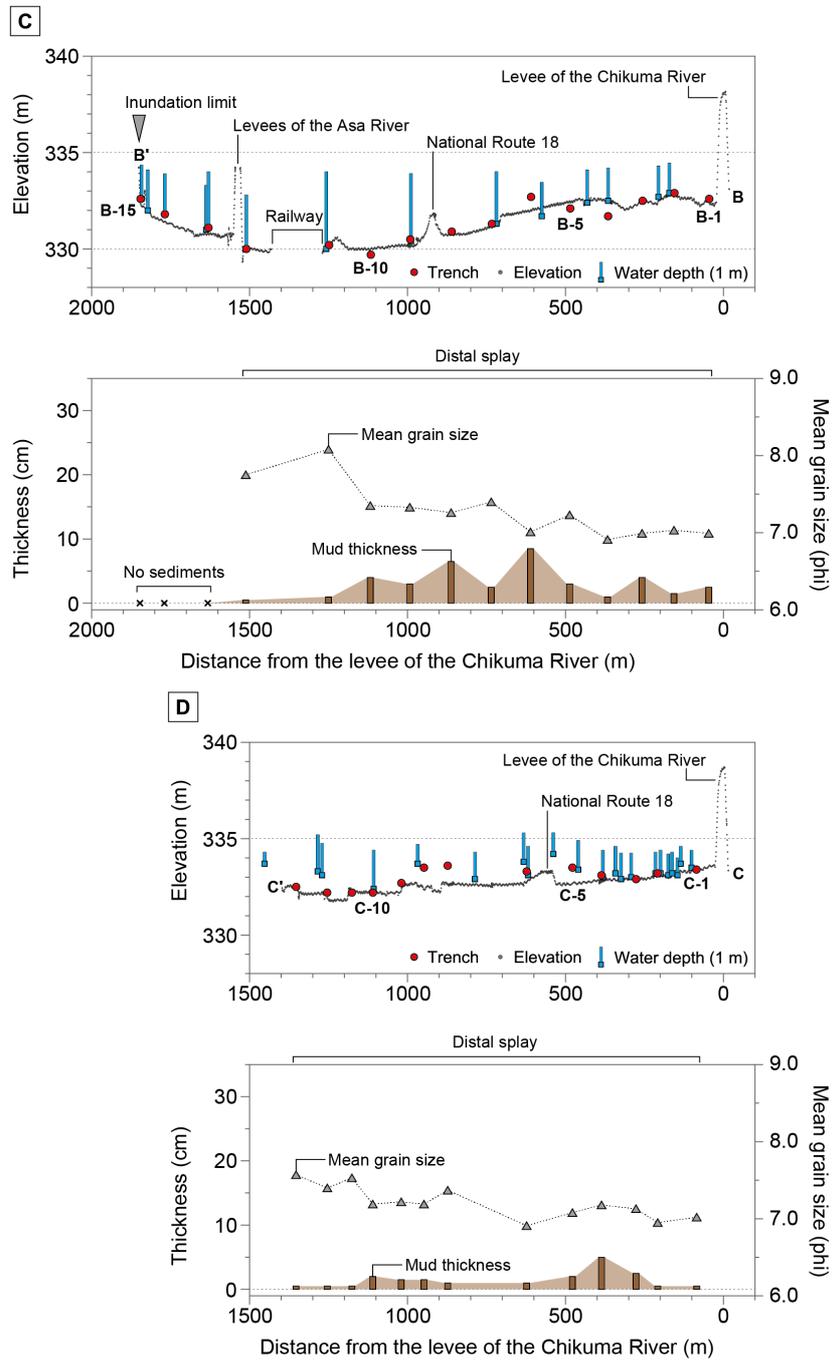
388 In contrast, the muddy layer of the medial and distal crevasse splay deposits
389 became thicker as the elevation decreased, in addition to the distance from the breached
390 levee (Figs. 8 and 9C, D). The strong negative correlation between elevation and
391 inundation water depth indicates that the water depth influenced the thickness of the
392 mud layer, implying that muddy sediments settled from a suspended load in stagnant
393 water. The upward-fining trend of the muddy layer also suggests suspension fallout
394 from the water column (Fig. 17).

664 **Fig. 8.** Measured elevation, water depth, and thickness, and mean grain size of crevasse
 665 splay deposits. (A) transect A–A' with trench locations (A-1 to A-19), (B) transects D–
 666 D' and E–E' with trench locations (D-1 to D-6 and E-1 to E-6), (C) transect B–B' with
 667 trench locations (B-1 to B-15), and (D) transect C–C' with trench locations (C-1 to C-
 668 13).

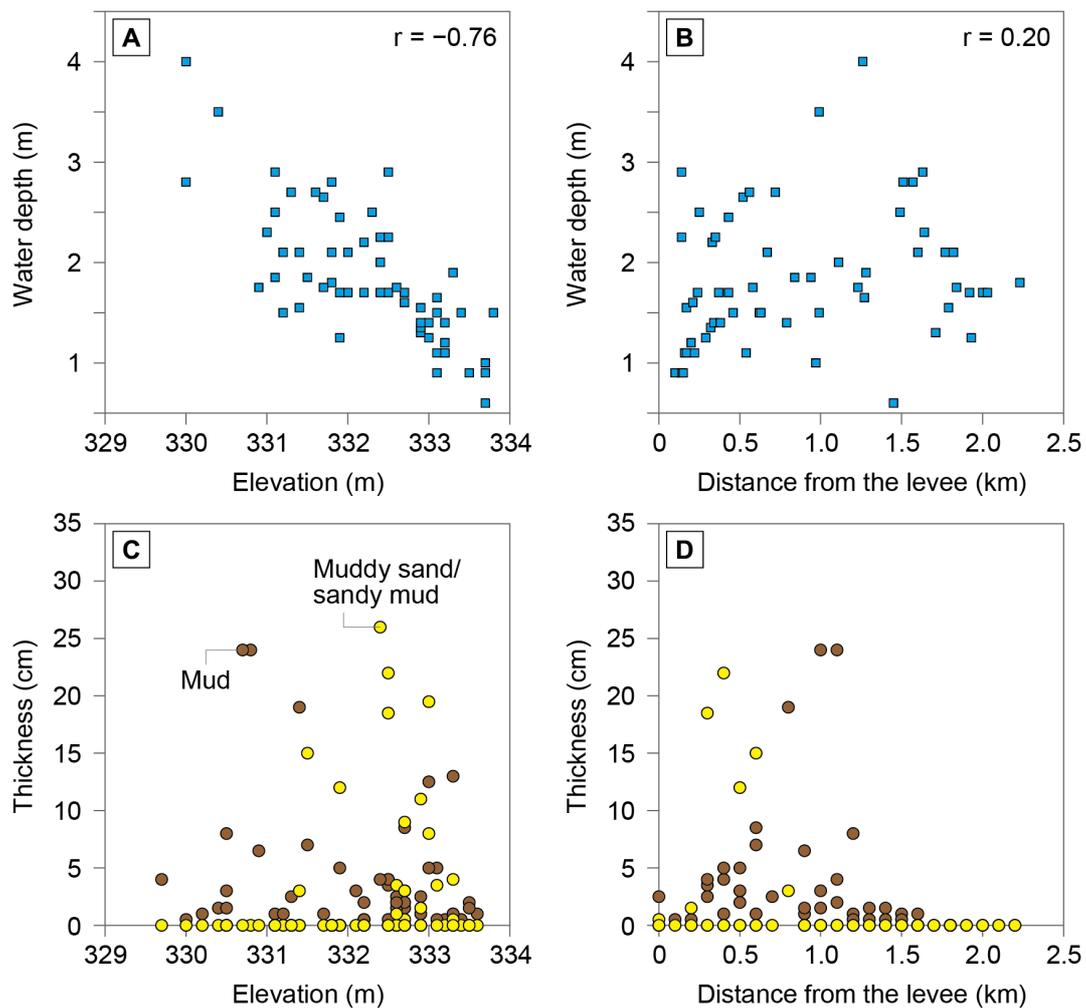
672 **Fig. 9.** Comparison between water depth and deposit thickness with elevation and
 673 distance from the levee. Relationships between (A) water depth and elevation, (B) water
 674 depth and distance from the levee, (C) thickness and elevation, and (D) thickness and
 675 distance from the levee. Note that (C) shows all data, including transects D–D' and E–
 676 E', whereas (D) shows data only for the river-perpendicular transects A–A', B–B', and
 677 C–C'.
