The Importance of Preserving Small Heritage Sites: the Case of La Tuiza Sanctuary (Zamora, Spain)

Received: 27 October 2021 / Accepted: 28 March 2022 / Published online: 8 April 2022

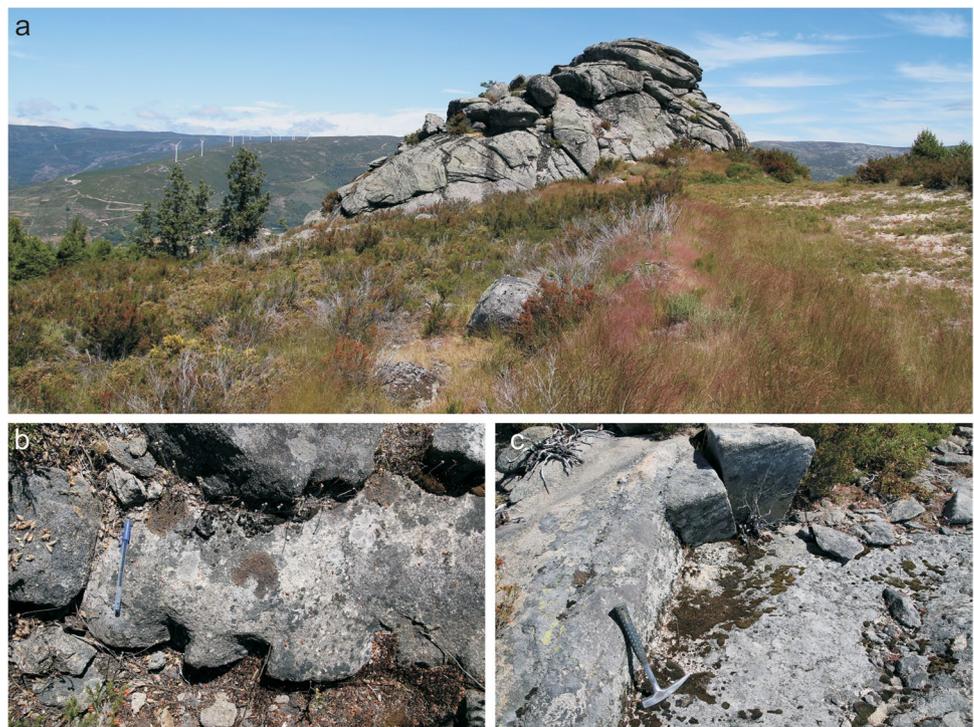
but still, it is possible to distinguish several historical marks of the masonry works such as wedges, cuts, indentations, abandoned ashlars, etc. (Fig. 3a–c). According to personal communication from the town hall staff, the only use of the quarry was for the construction of the sanctuary at the end of the eighteenth century, with no evidence or any indication suggesting its later use. Regarding transport, it was the locals themselves, with their oxen and carts, who hauled the stones from the quarry to the sanctuary.

With regard to the extraction methods, in this type of quarries the most traditional method was the use of wedges to pre-cut the blocks, although there are no references to whether the material used was wood or metal. In this case, no marks of oxidation of the wedge holes were observed, which leads us to think that wood may have been used (Fig. 3b, c). In

Fig. 3 a General view of the granite outcrop where the quarry was opened. b Wedge marks on stone. c Block cutting marks

No drilling marks were found either, so the use of explosives to cut blocks can be also ruled out.
